USS Charles F Adams DDG-2 Philadelphia Open House

May 17-18, 2010

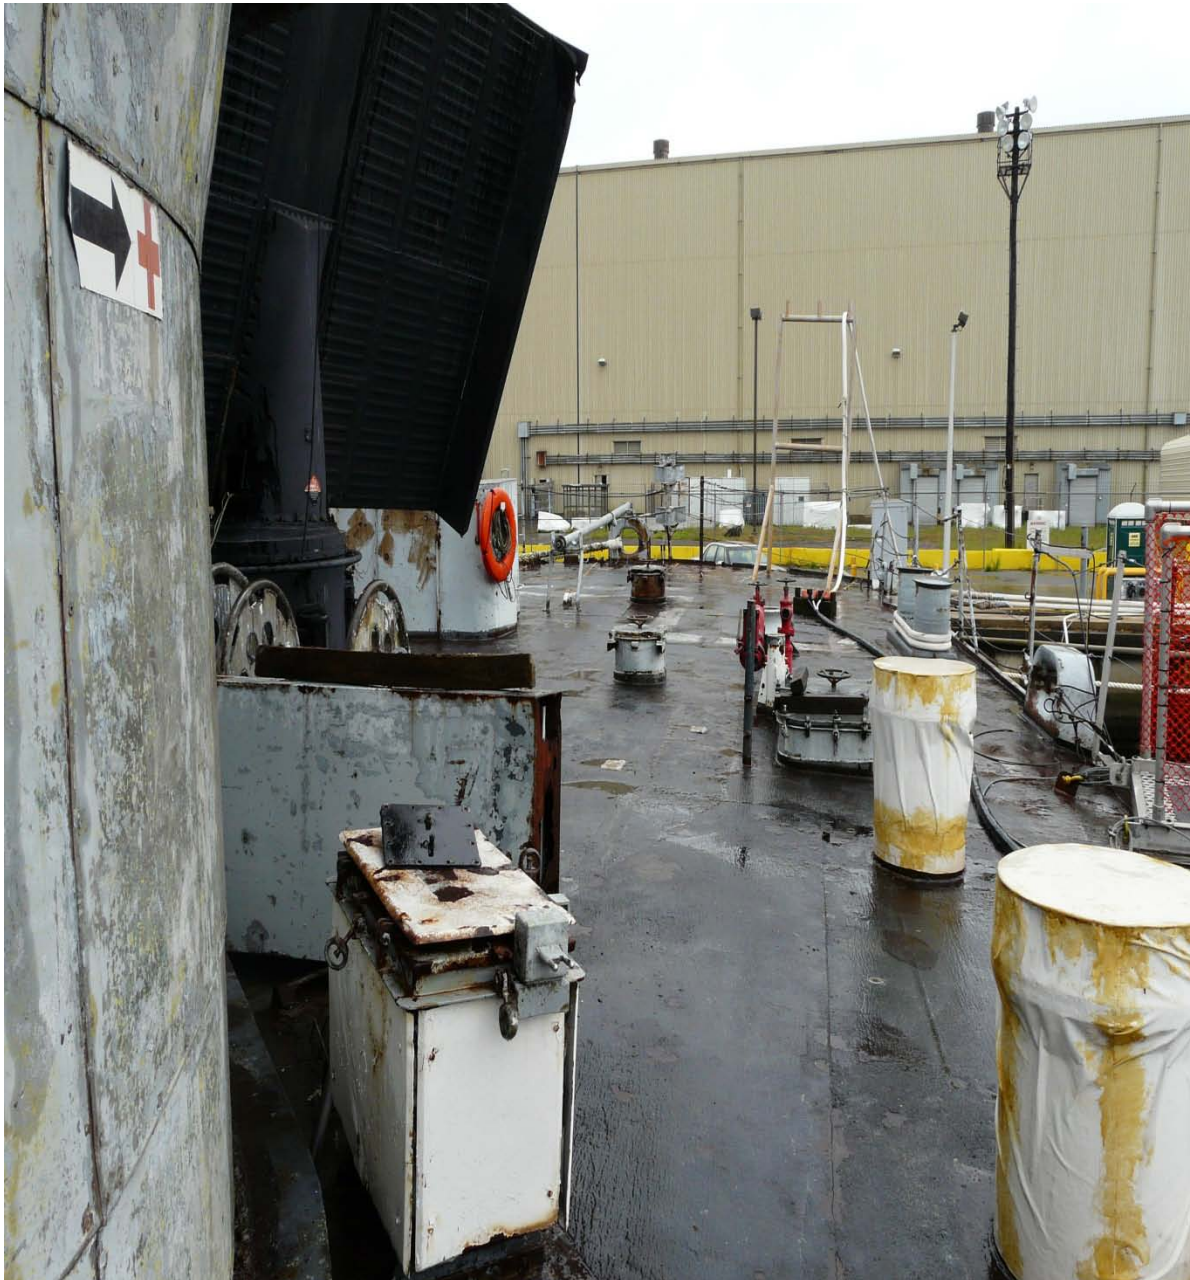
Port side looking aft

39 radar is bolted to a bracket that is welded to the main deck. Note that the air vents are sealed to prevent water infiltration. Also take note of the two storage lockers that are rusting. This is causing the rust stains that you see on the side of the ship. The main deck was coated with a clear sealer to inhibit rusting. However non-skid is flaking off.

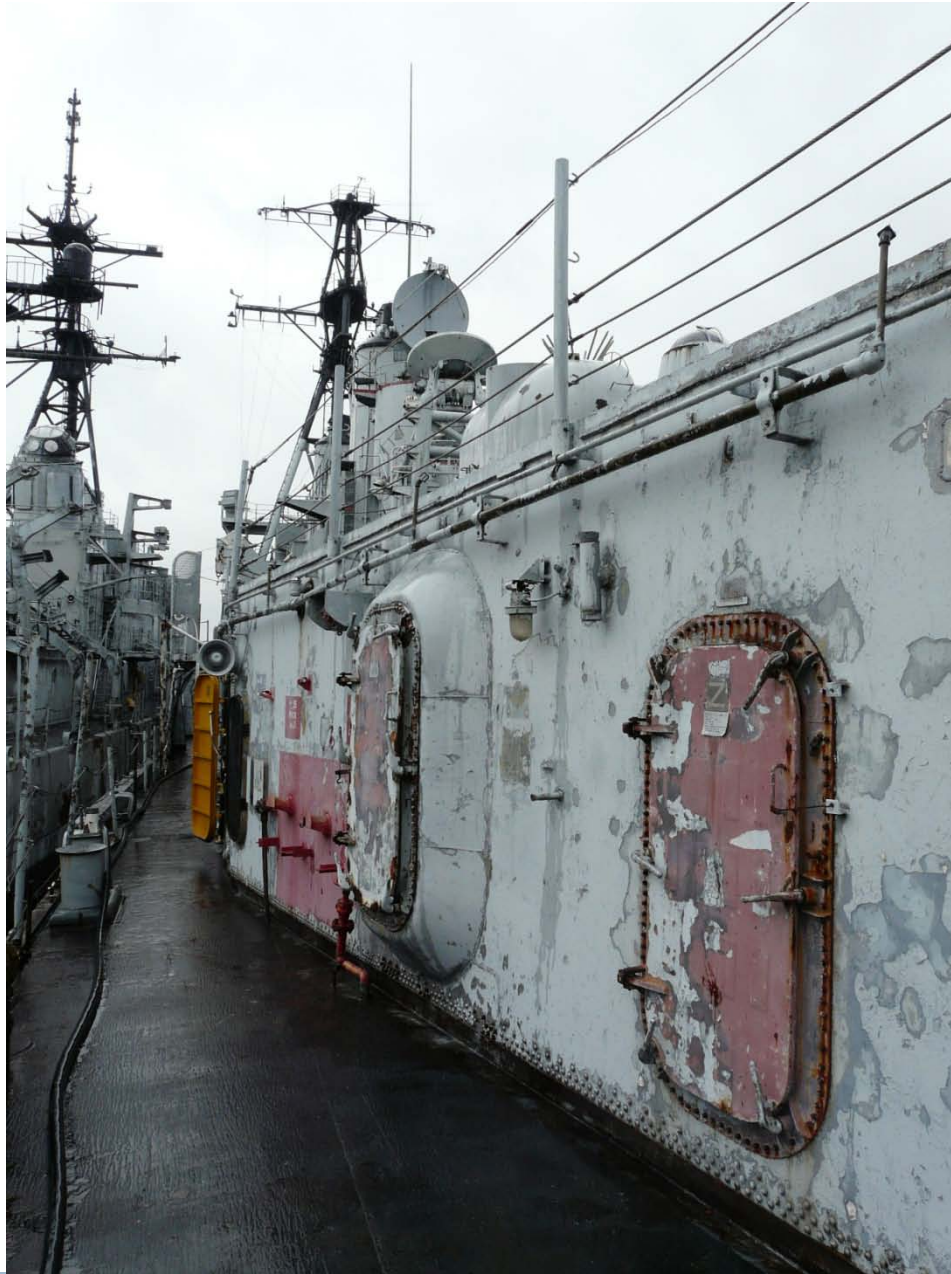
PORT SIDE AFT

Port side looking forward on the main deck. Note that the aluminum bulkheads had the paint flakes power washed off two years ago when a fresh coat of paint was applied to the hull from the waterline up to the main deck. The only rust you are seeing is on the water tight doors. Some doors will need replace while others can be repaired.

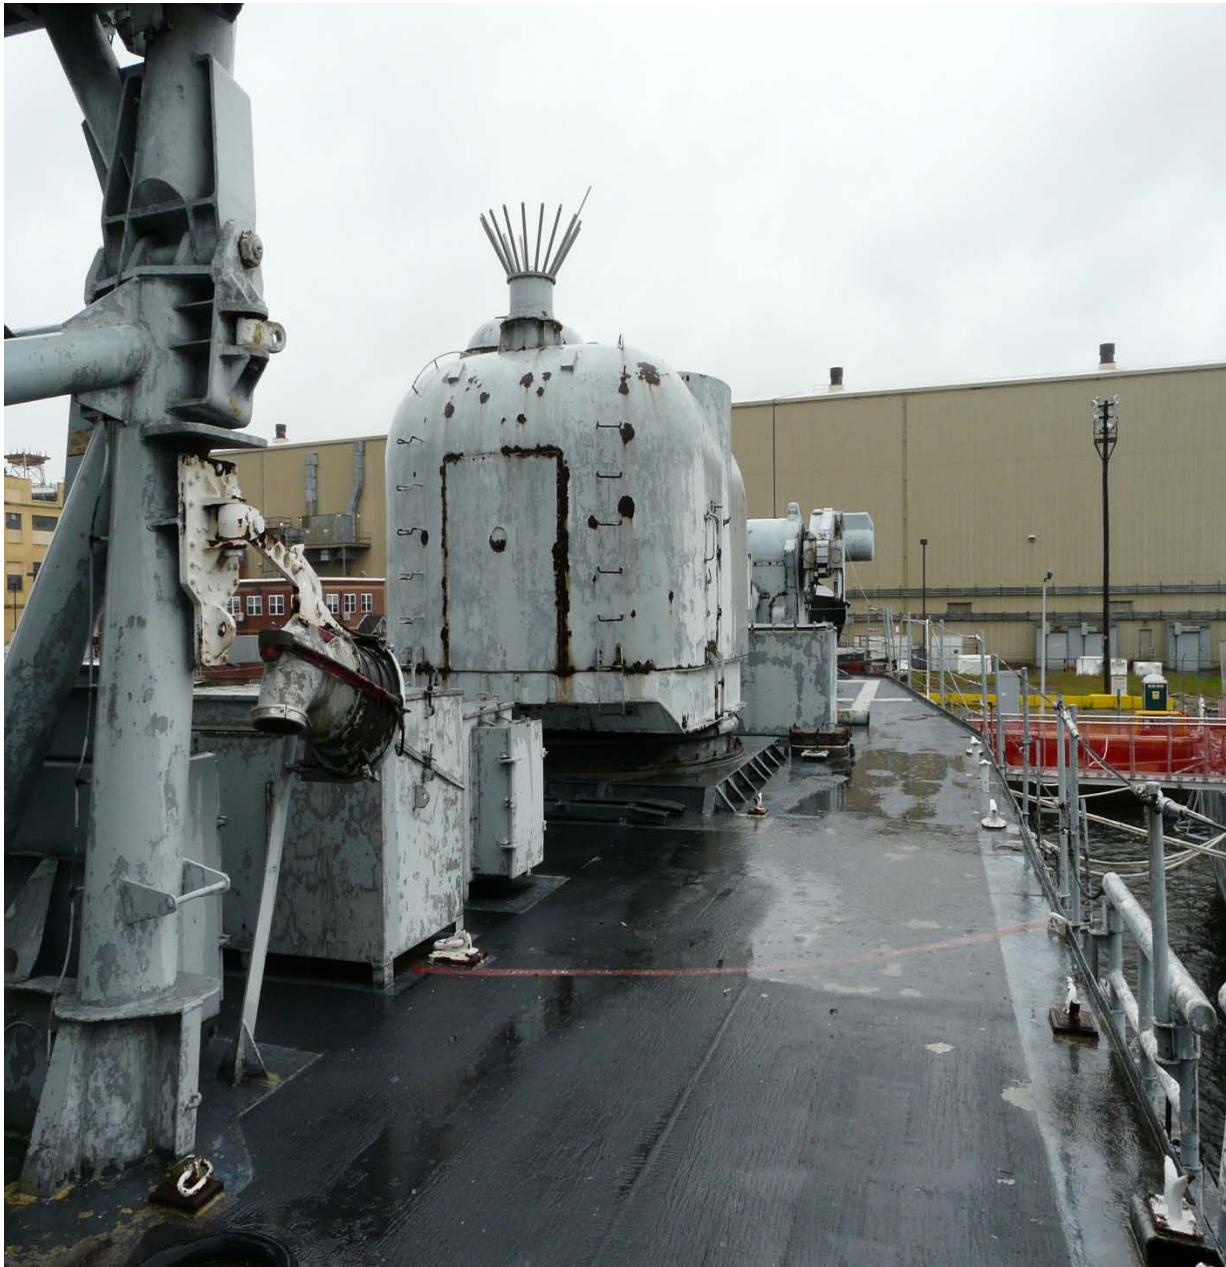
01 Level looking aft

The bird cage antenna on Gun Mount 52 has been cut down. There is some rust on the gun mount and missile launcher.

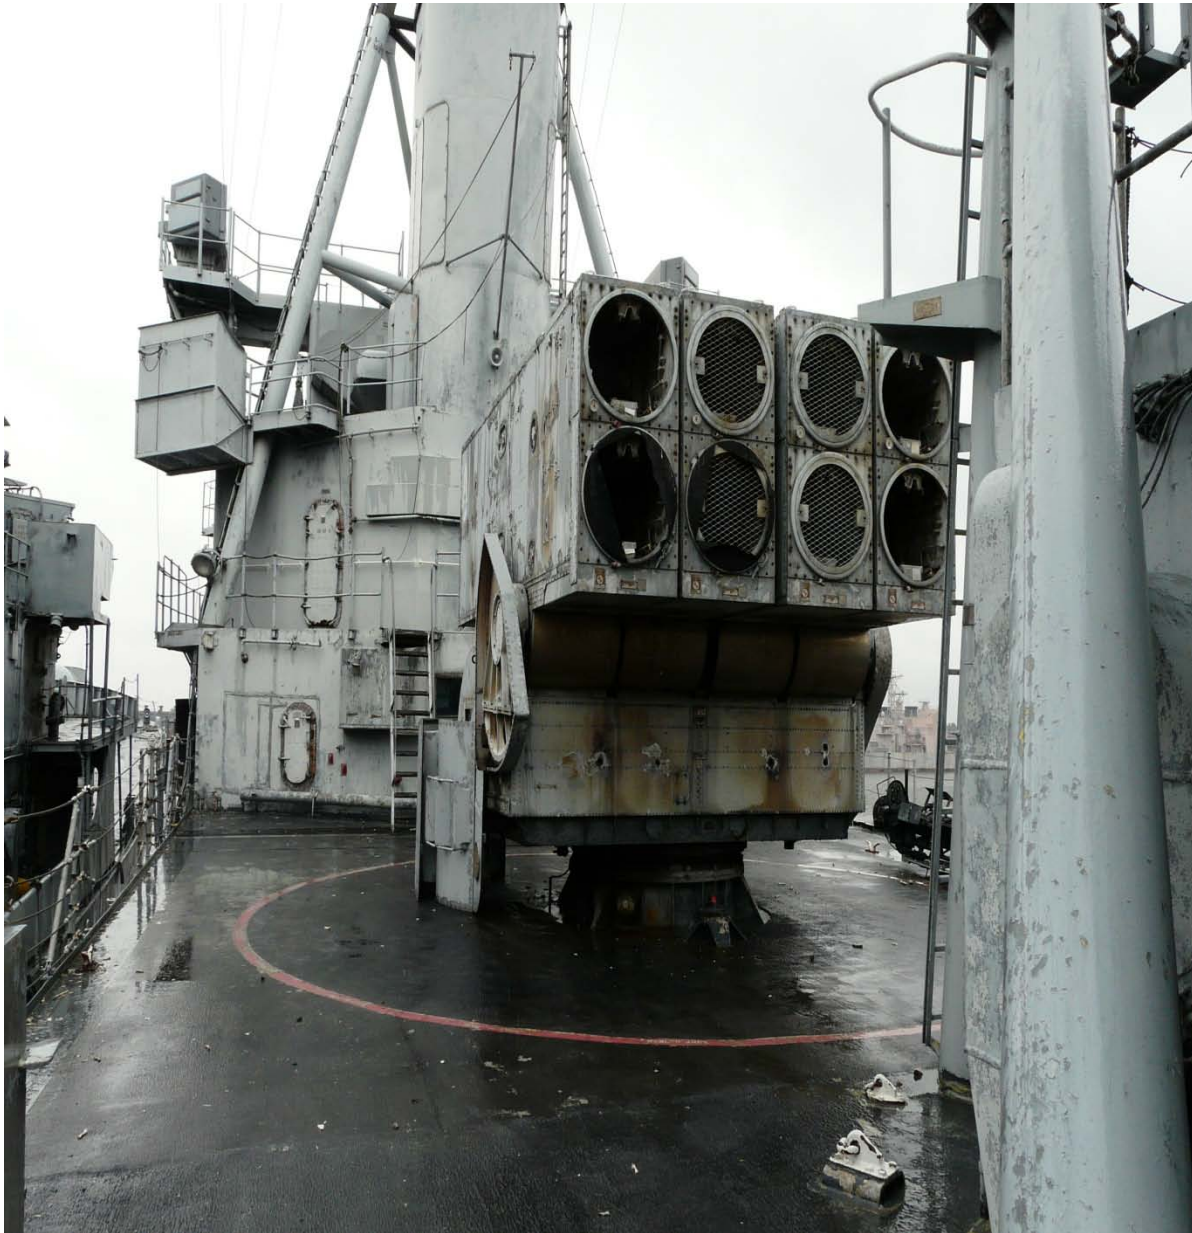
ASROC Deck

The ASROC Launcher does have rust all over but it is of the surface type. The cell covers are torn and will need replaced. Panels on the backside of the launcher need to be bolted back on. Take note just above the flag locker on the left upper part of the picture. The SLQ-32 Electronic Warfare Antennas are both still on the ship.

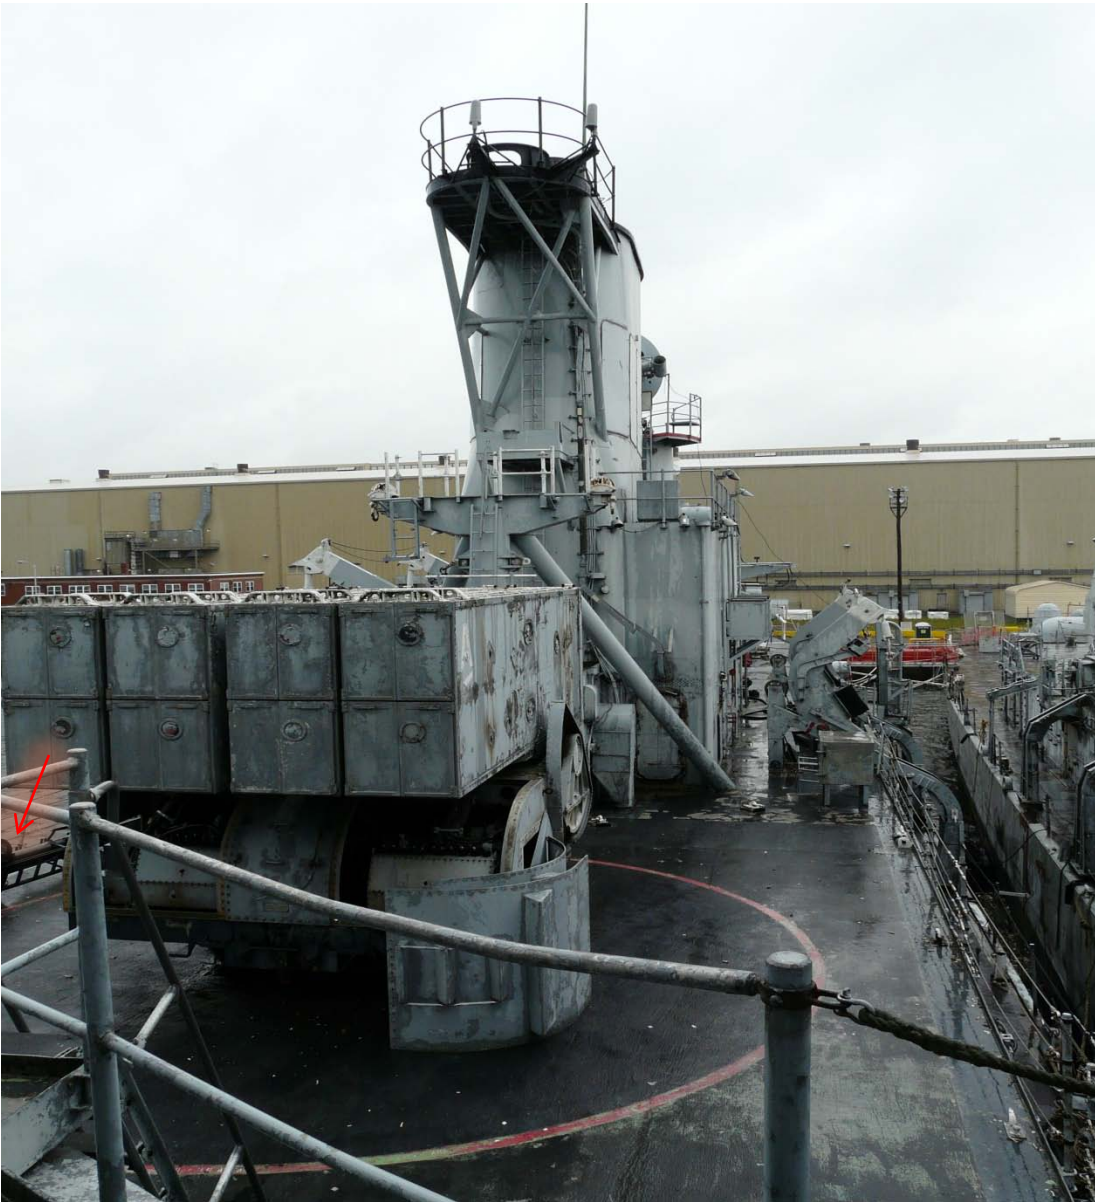
02 Level looking aft

You can see the covers to the front part of the ASROC Launcher leaning against the launcher. The 39 Radar which is normally mounted on the aft stack is missing and is welded on the fantail. Look at the red arrow on the left side of the picture. The item it is point to is the top part of the main mast that is setting on the deck.

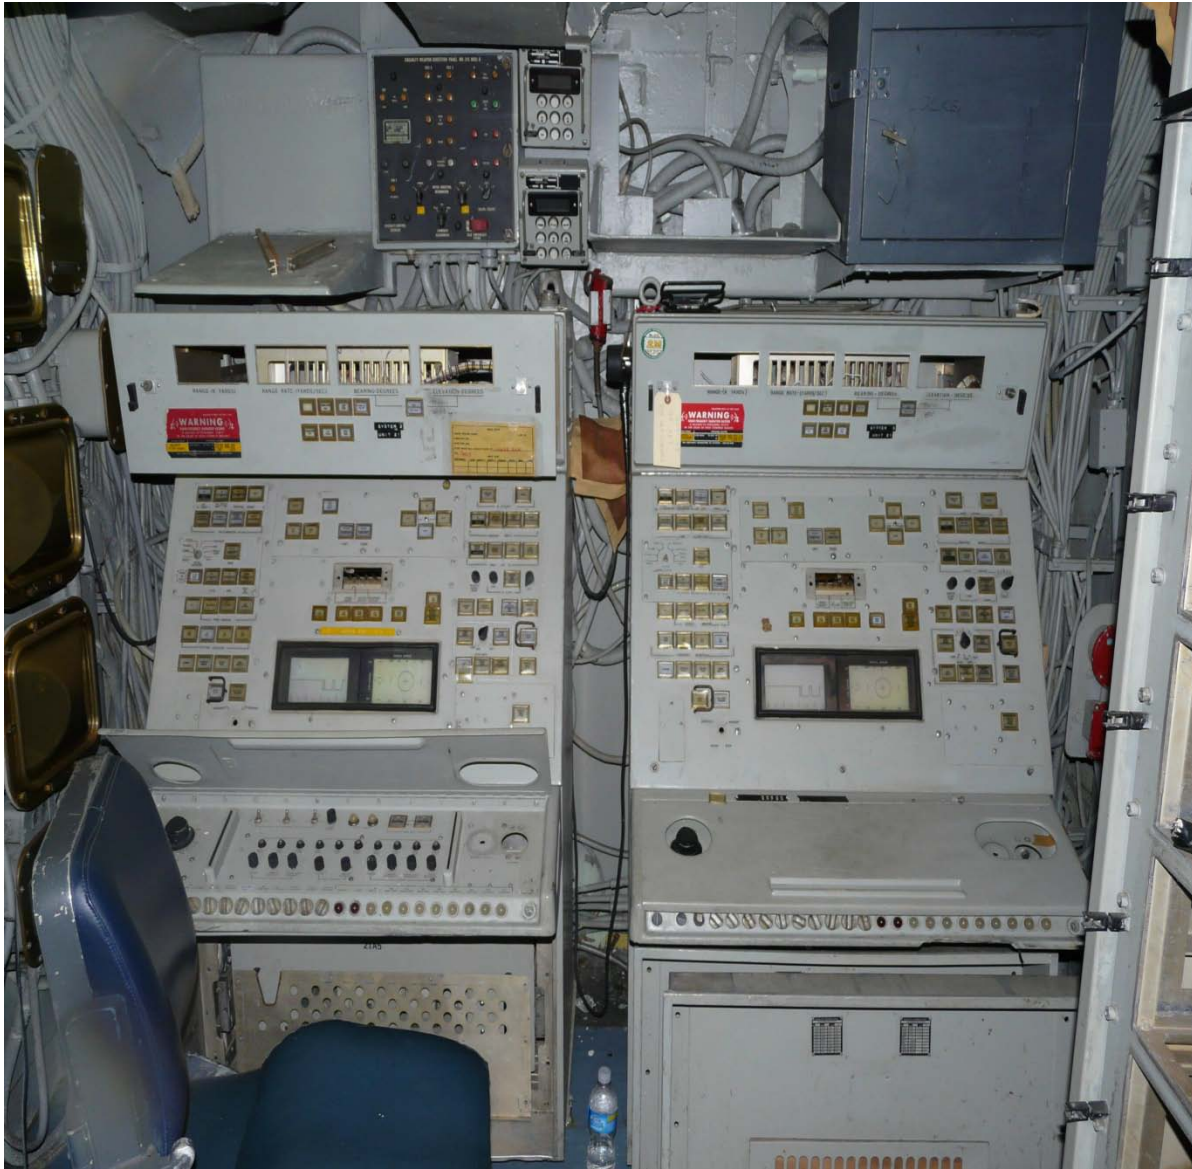
Missile Radar

These are the two radar consoles for the 51 radars. They have had some DEMILING done to them. They are located up a port side vertical ladder just forward of the aft gun mount on the 01 level.

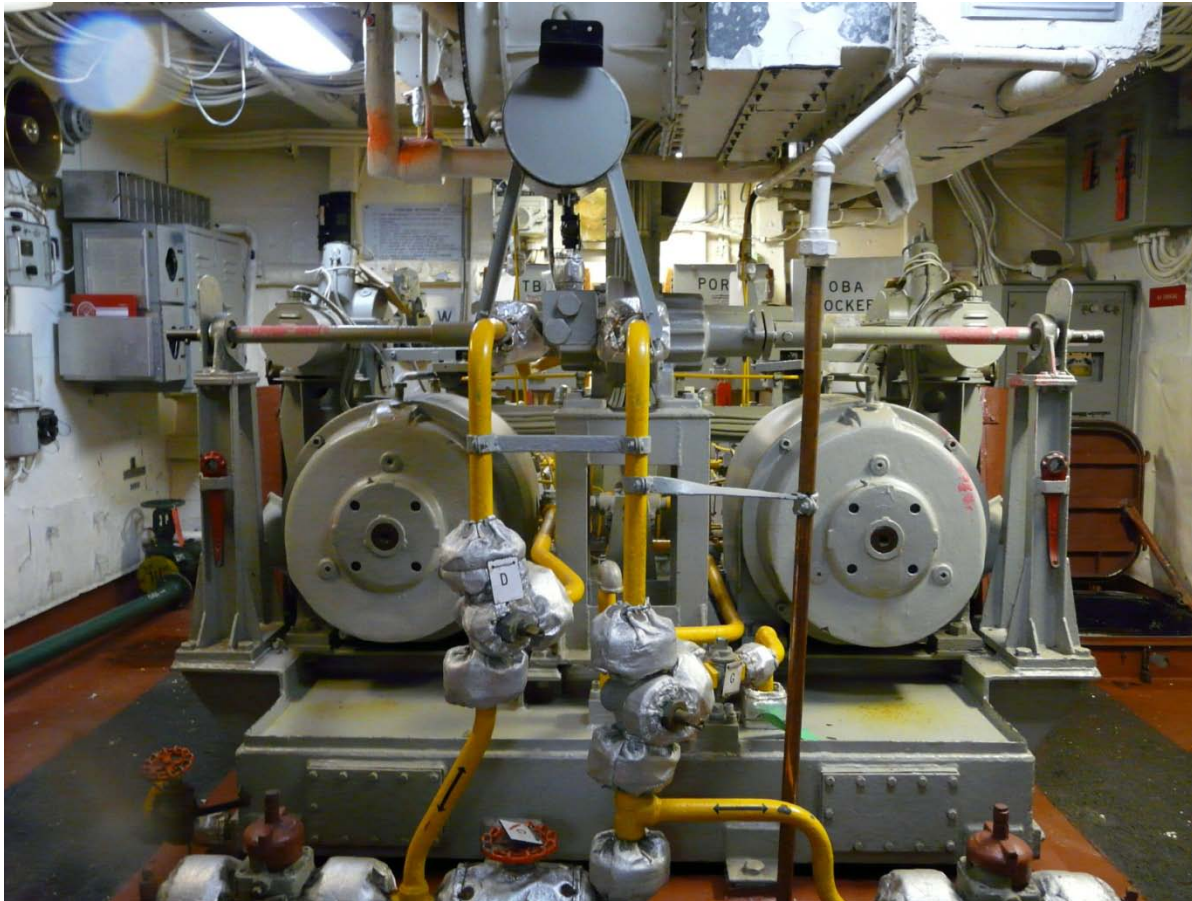
After Steering

This space is in excellent condition. Some minor repairs needed to the steering units is needed.

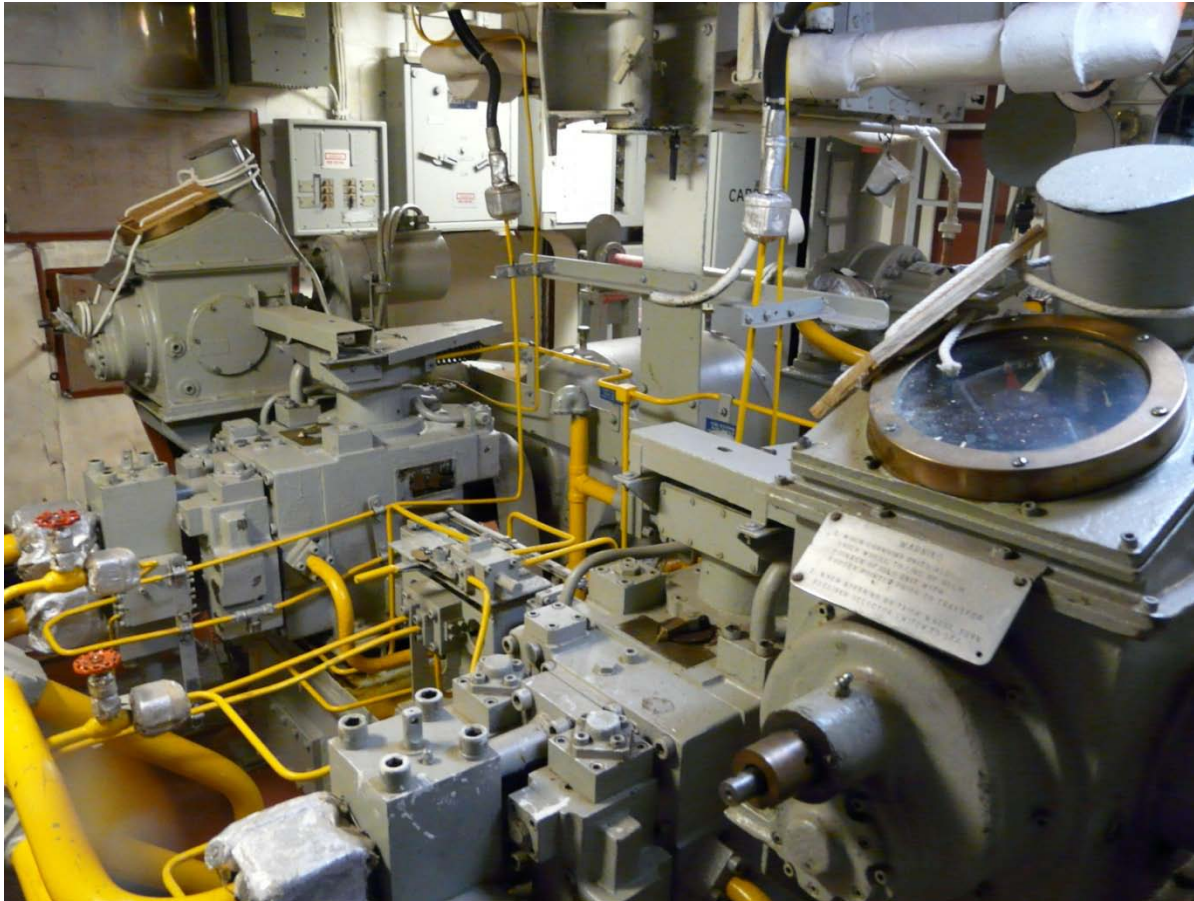
After Steering Units

Take note that the steering indicators are not smashed. The only items that appear to be missing are the small steering wheels on the port and starboard units.

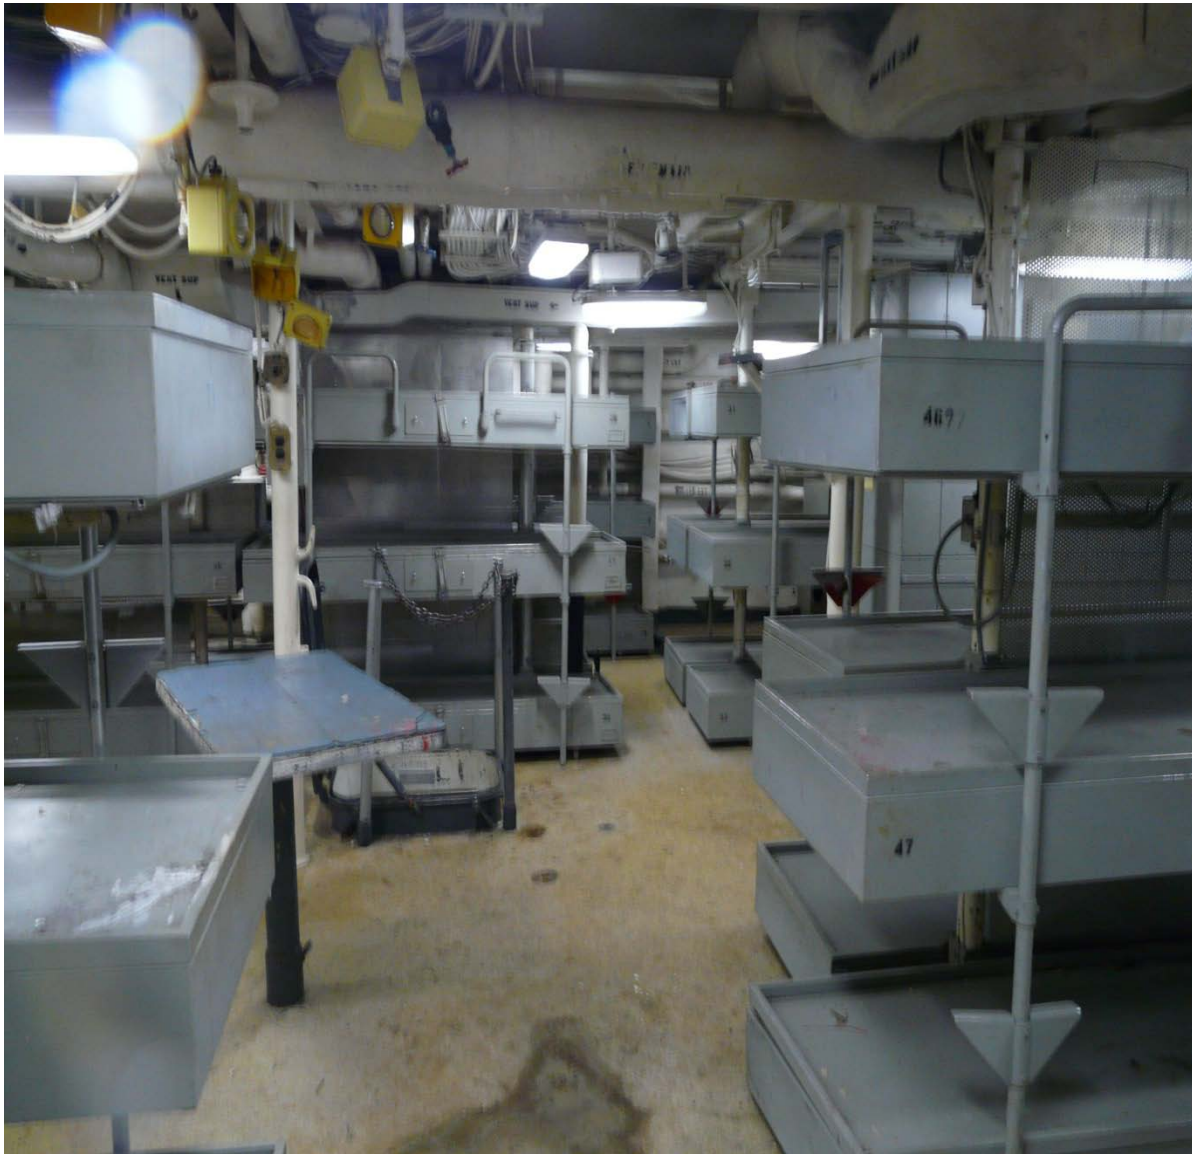
Engineering Berthing

All racks are present though some have been unbolted and pushed aside. The deck in this space will need to be upgraded.

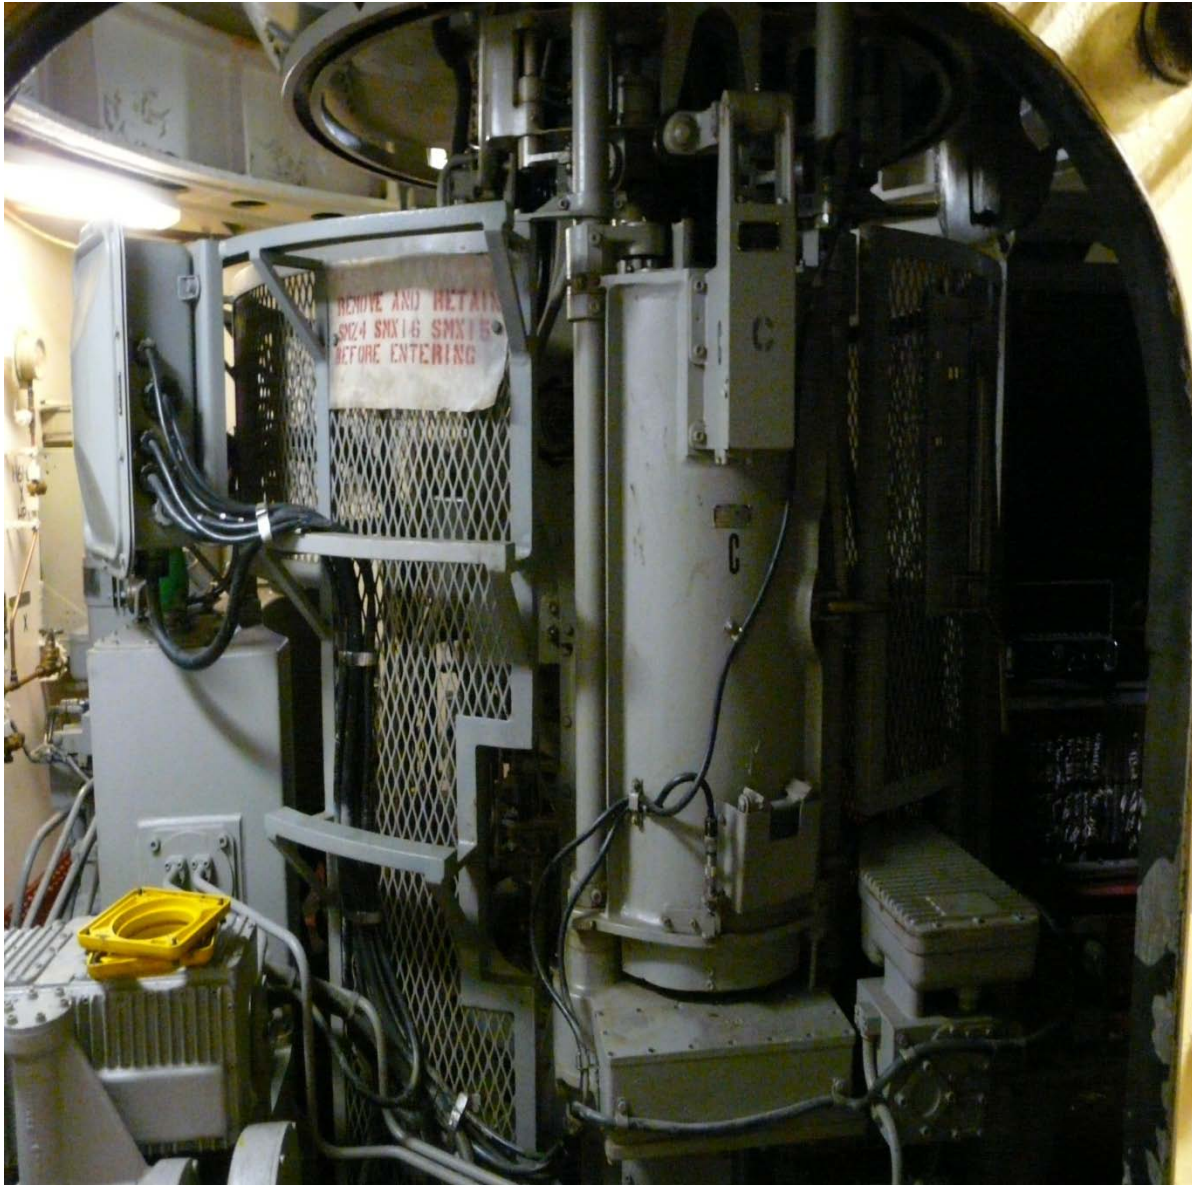
MT 52 Carrier Room

This is MT 52's carrier room just forward of the aft head. The DEMIL that took place in this space was to the EP 1 & 2 panels to the right which can't be seen in this photo. There is some hydraulic fluid on the deck, but even when the ships were in operation there always seemed to be some fluid on the deck.

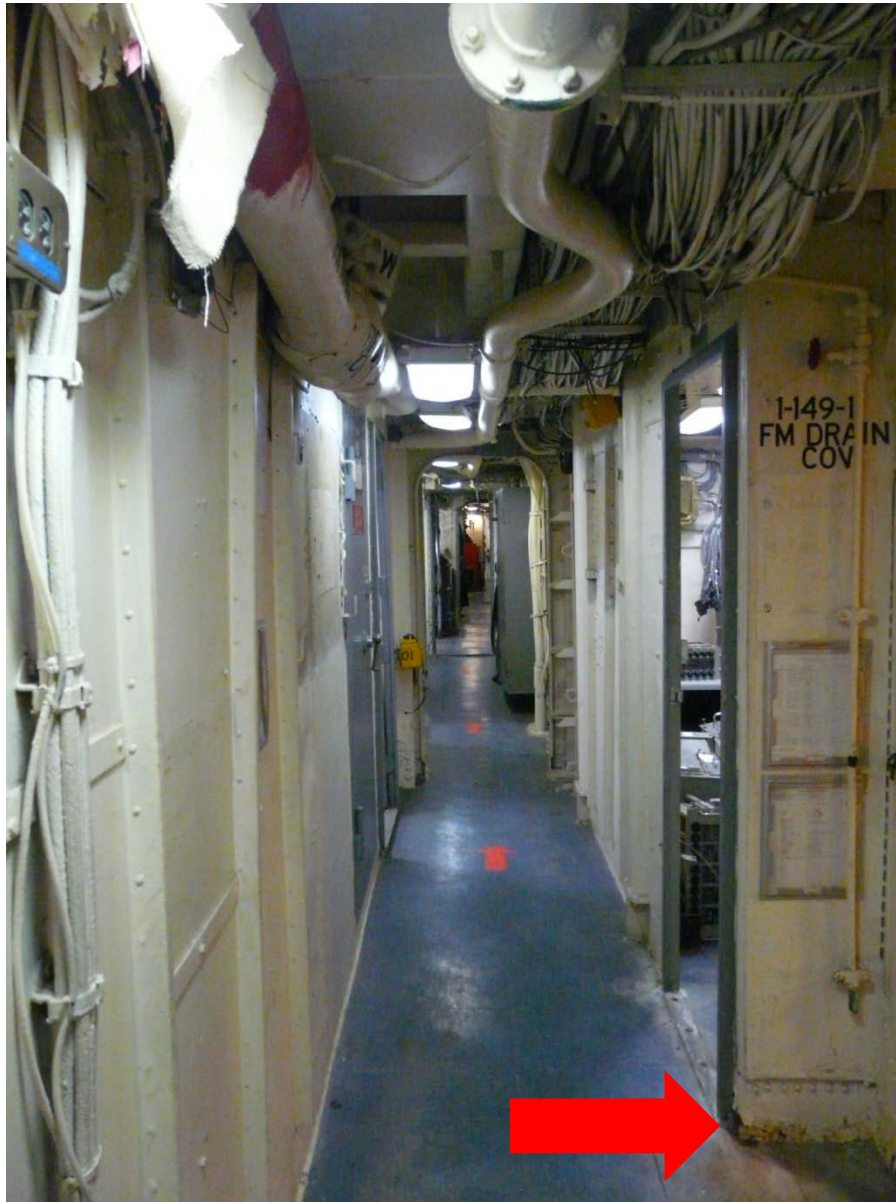
Main Ship Passageway Aft

This was taken from the MT 52 Carrier Room looking forward. As you can see the tile are coming off the deck and will need to be replace with a terrazzo type deck. Look at the red arrow point right. There are places through out the ship where there is rust that connects the bulkhead to the deck that will need repaired. For the most part, spaces will need to have flaking paint removed, wiped down, and repainted.

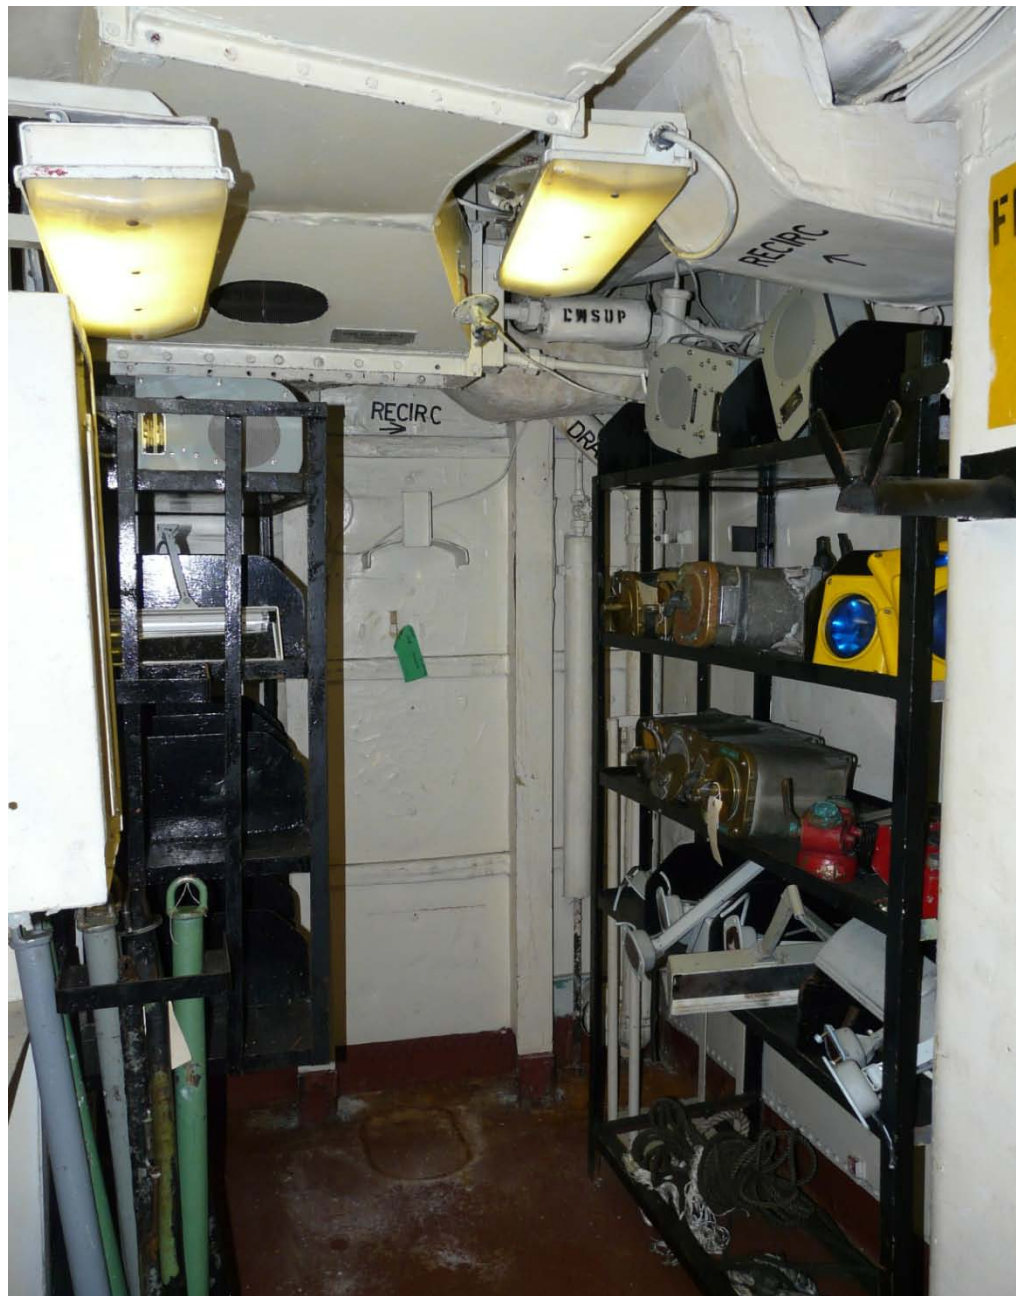
Damage Control Locker Repair 5

Repair 5 is in good shape like most of the interior spaces. It will need flaking paint removed, a good wipe down, and lastly repainted before restocking it with damage control equipment.

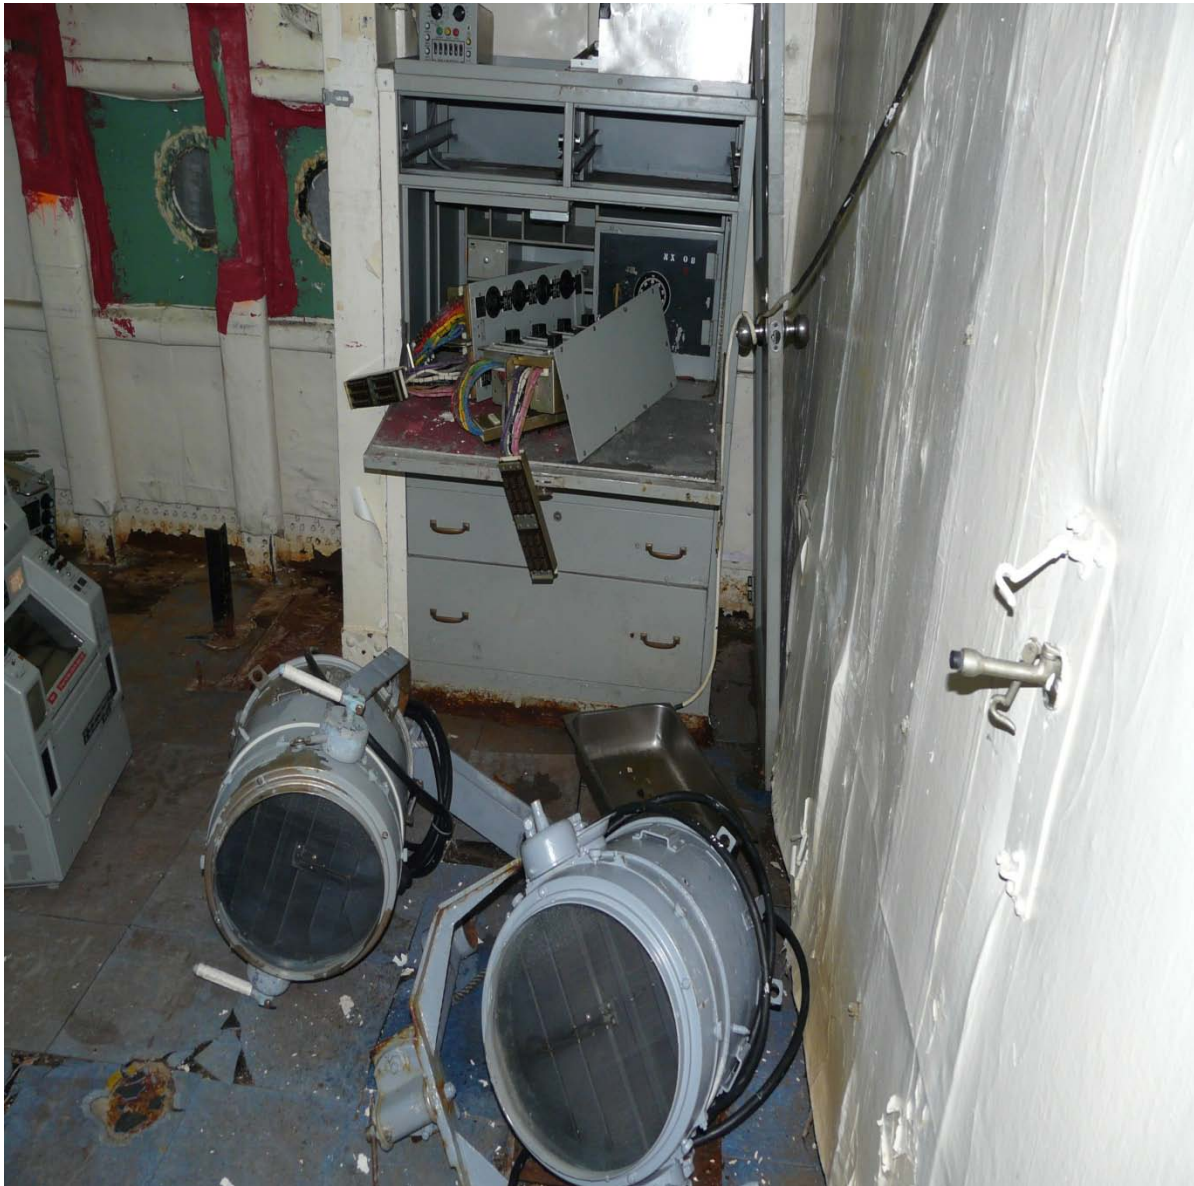
Office Space

Here are the two signal lights that were removed from the USNS Saturn during open house. This is one of those spaces that will need work done to repair the rust issues where the bulkhead meets the deck.

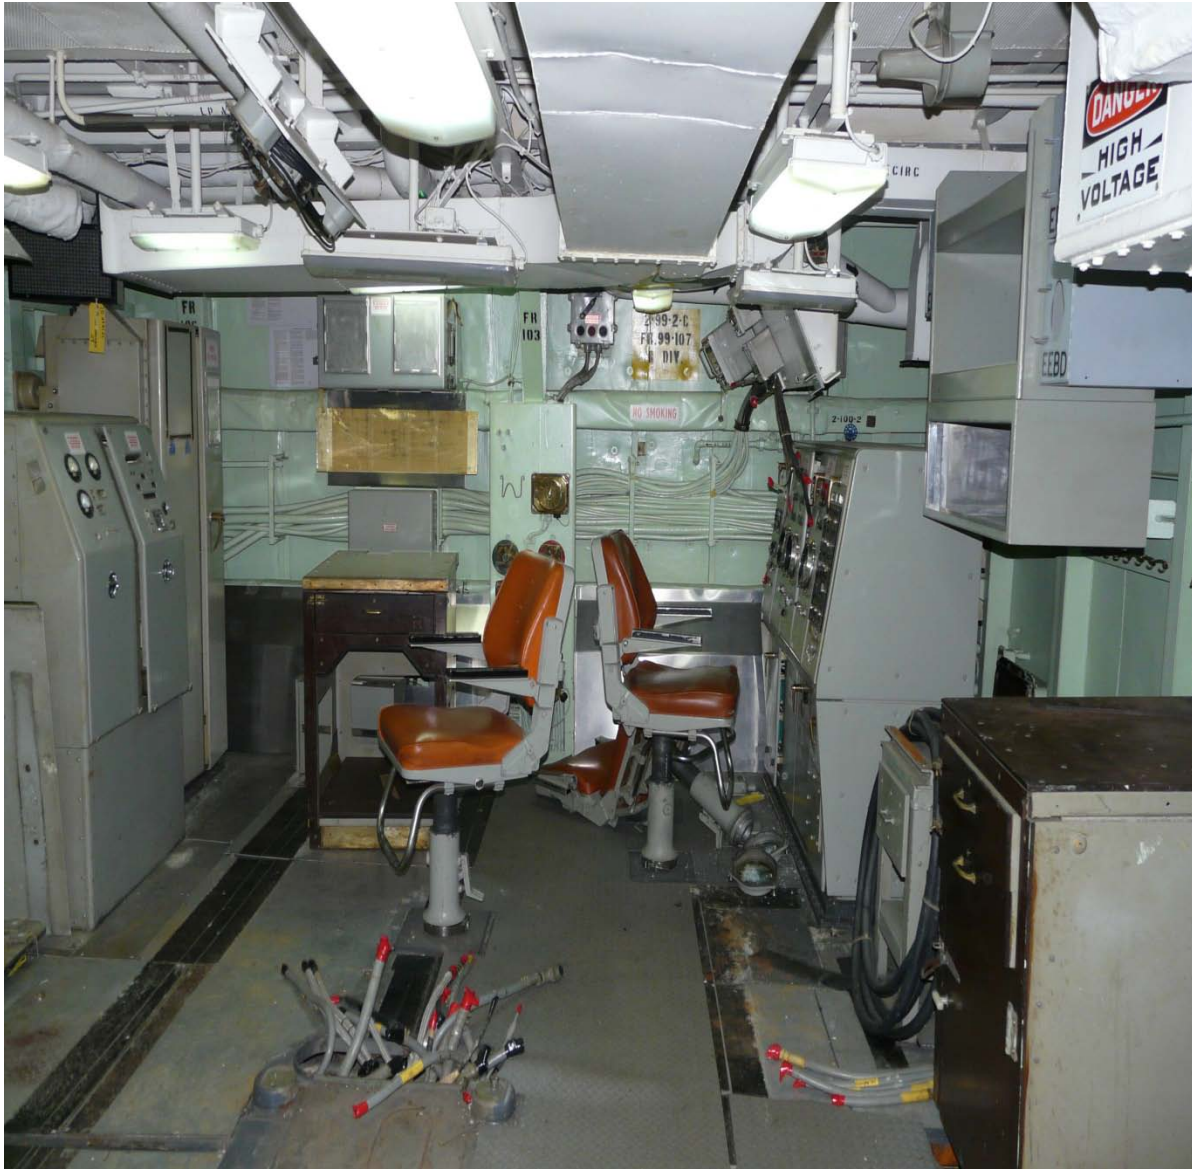
Gun Plot

Taken from the door looking in. As you can see, whatever equipment was mounted in the center of the compartment is missing. This is part of the digital upgrade Adams had. On other Adams Class ships a MK47 Analog Computer was mounted here and took up the entire center section of the compartment.

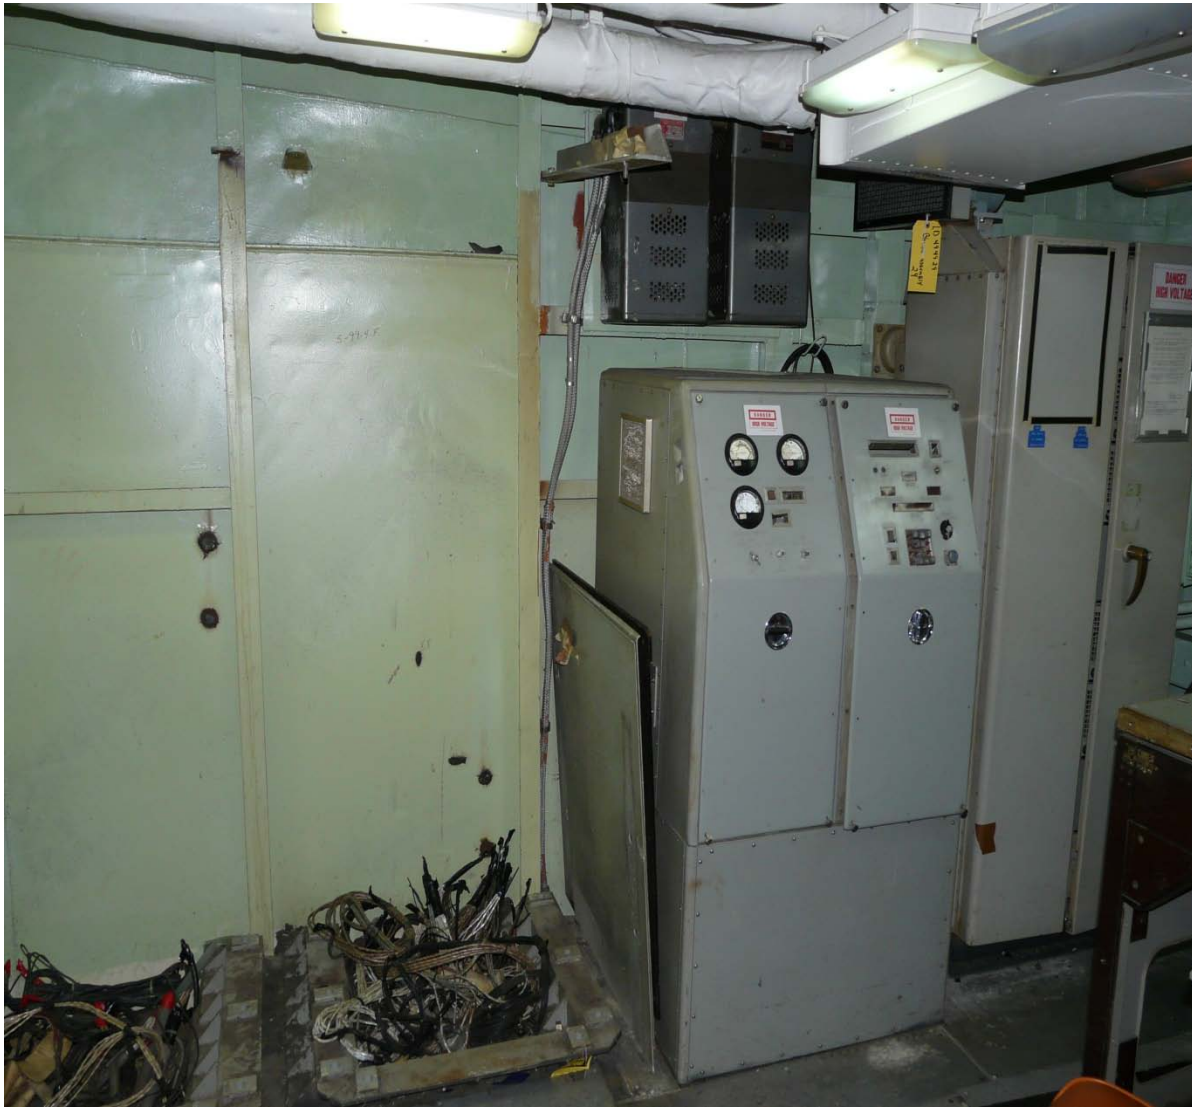
Gun Plot

Here is the aft bulkhead of Gun Plot. On the left you can see that the fire control switchboards are missing. We have identified the company that manufactures these and they are still making them. They also make a great deal of navy IC equipment.

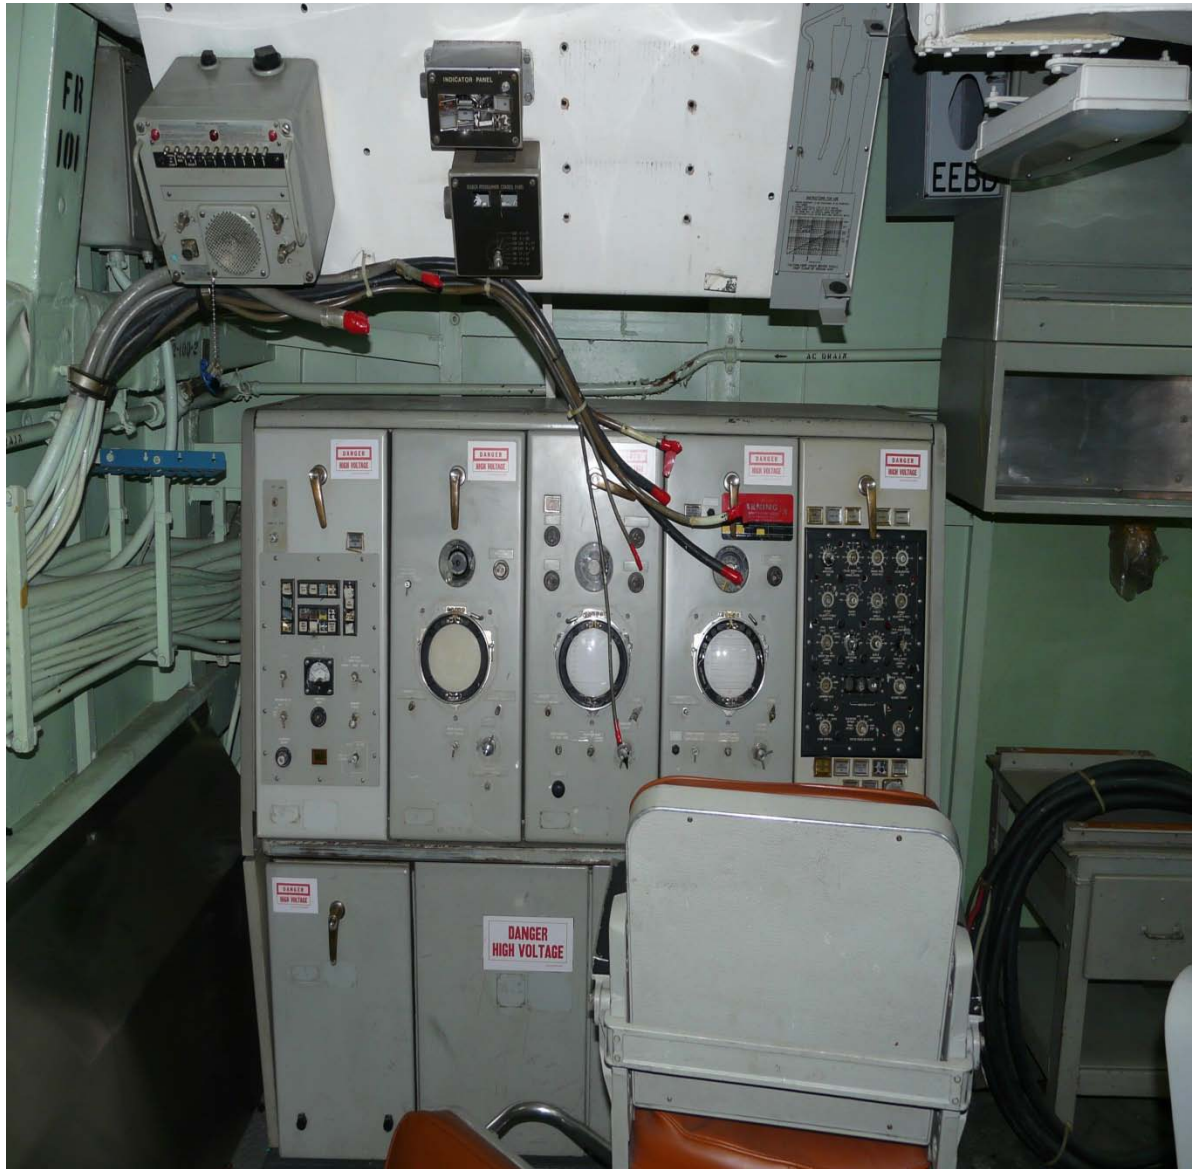
The AN/SPG-53F Radar is located in Gun Plot. The knobs and push buttons have been DEMILED as was the inside of the cabinet.
