USS Charles F Adams DDG-2 Philadelphia Open House

May 17-18, 2010

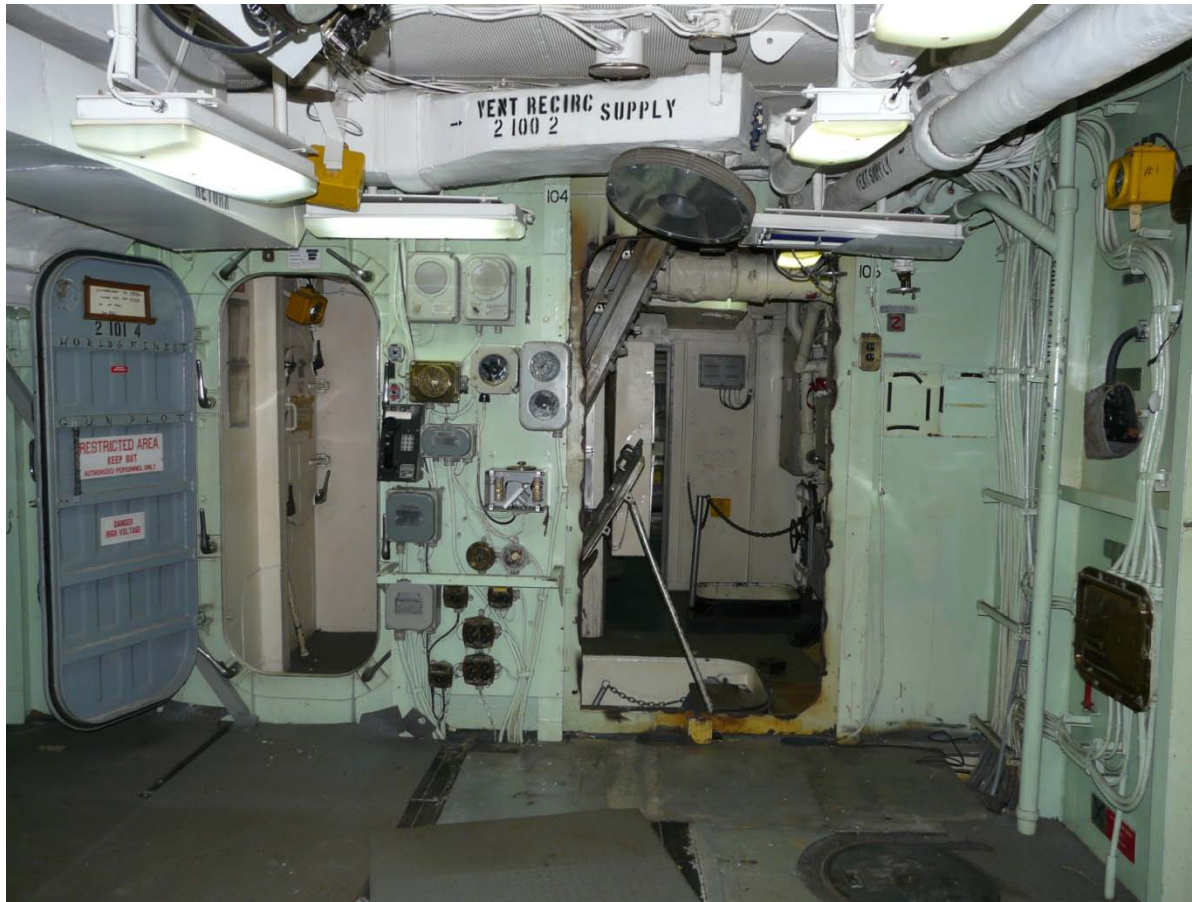
Gun Plot

Taken from the port side looking towards amidships. A section of the bulkhead was removed to remove equipment. That section of the bulkhead is still there in DC Central and needs welded back in place.

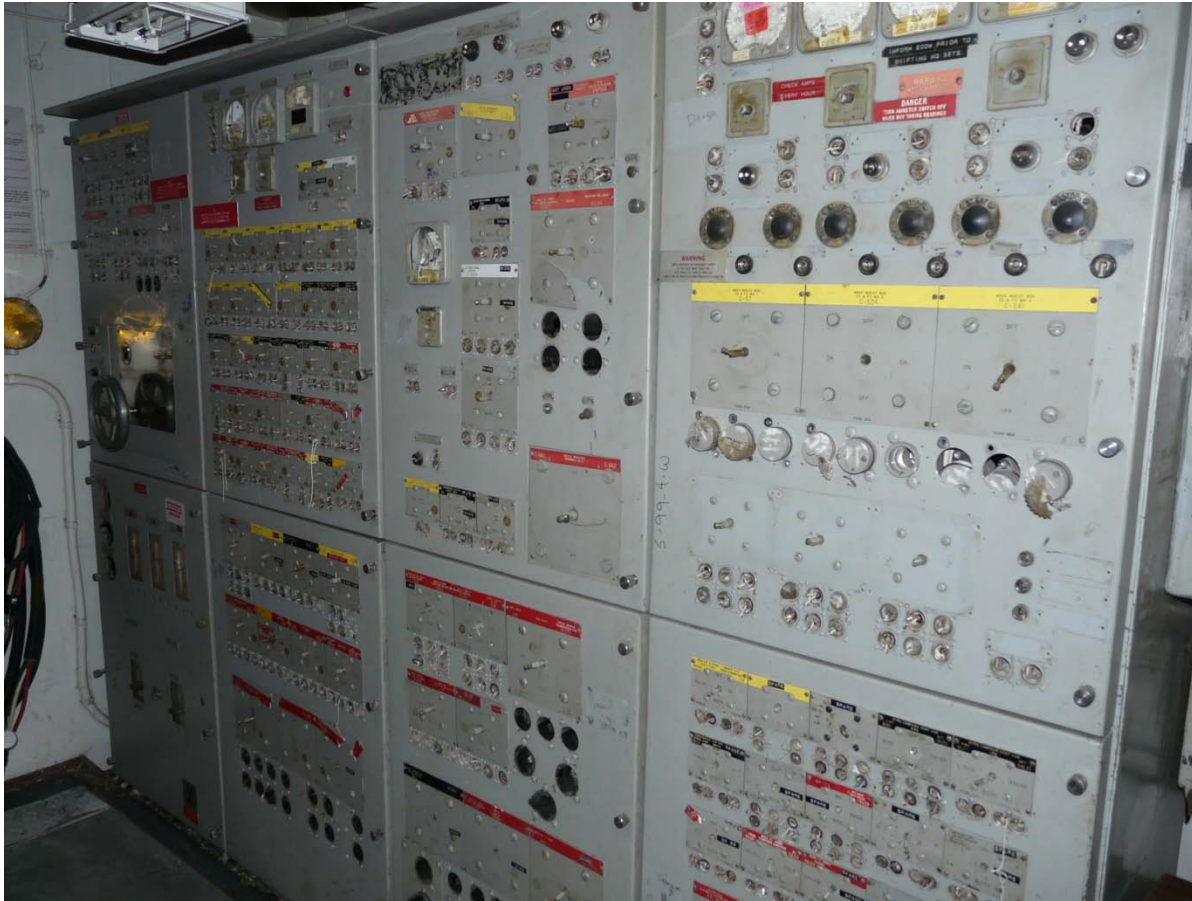
Here is the IC Switchboard in the IC Room which is two decks down from the Mess Decks. It also has been DEMILED with the fuses and switches busted off.

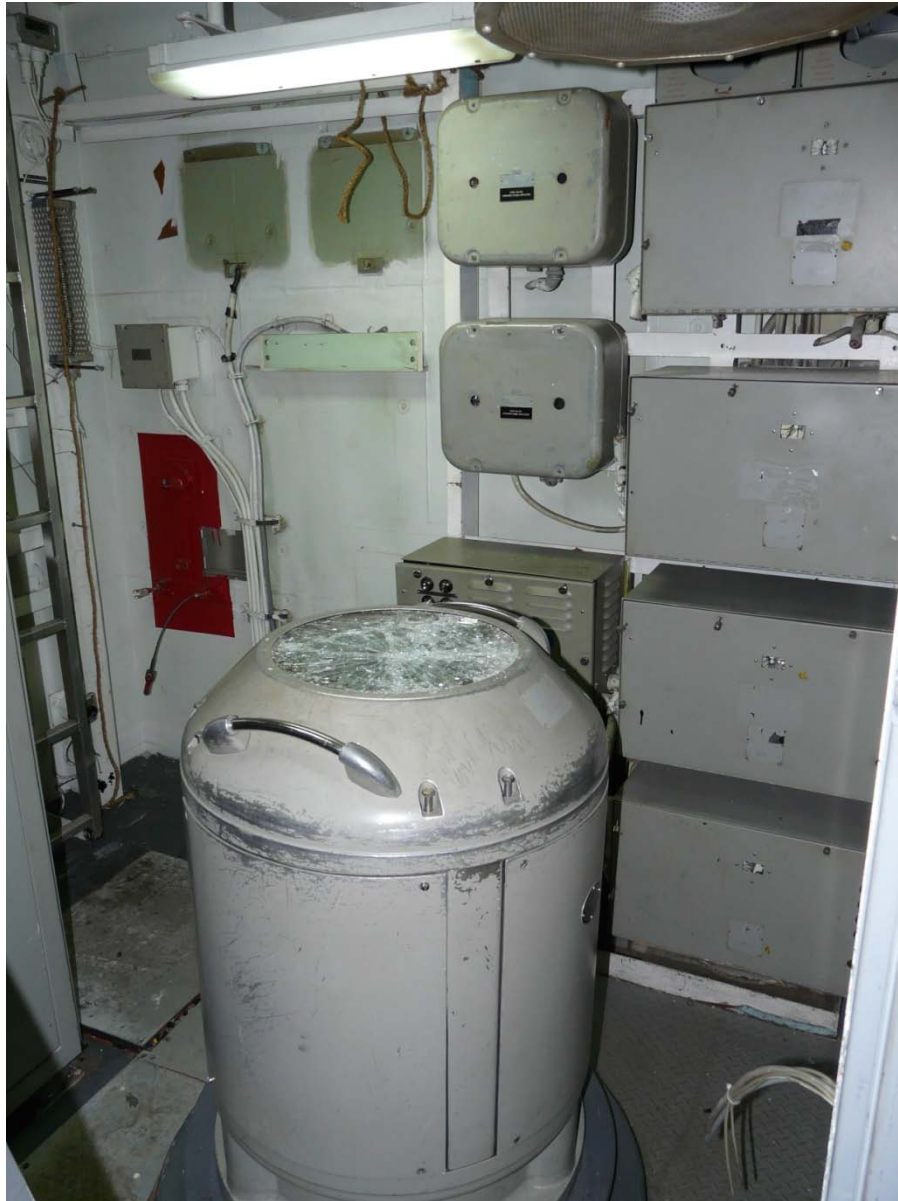
Ship's Gyro

Located at the bottom of the ladder and to the left in the IC Room. The glass was smashed on top of it but the indicators under the smashed glass were not damaged.

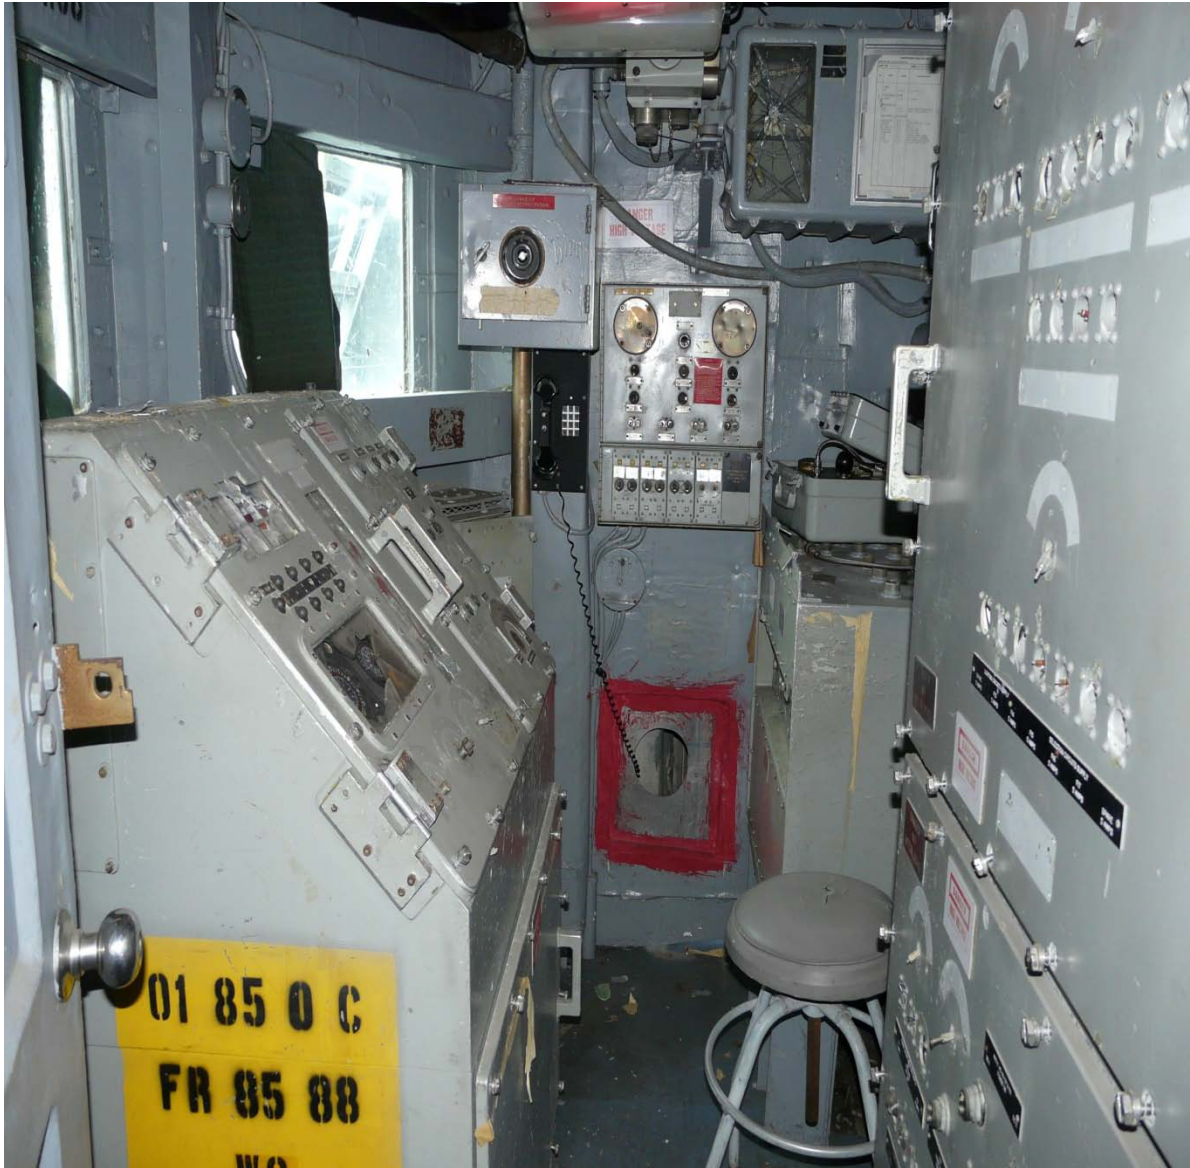
ASROC Launcher Control

This is forward of the ASROC Launcher. Looking out the windows you can see the ASROC Launcher. This space has been DEMILED.

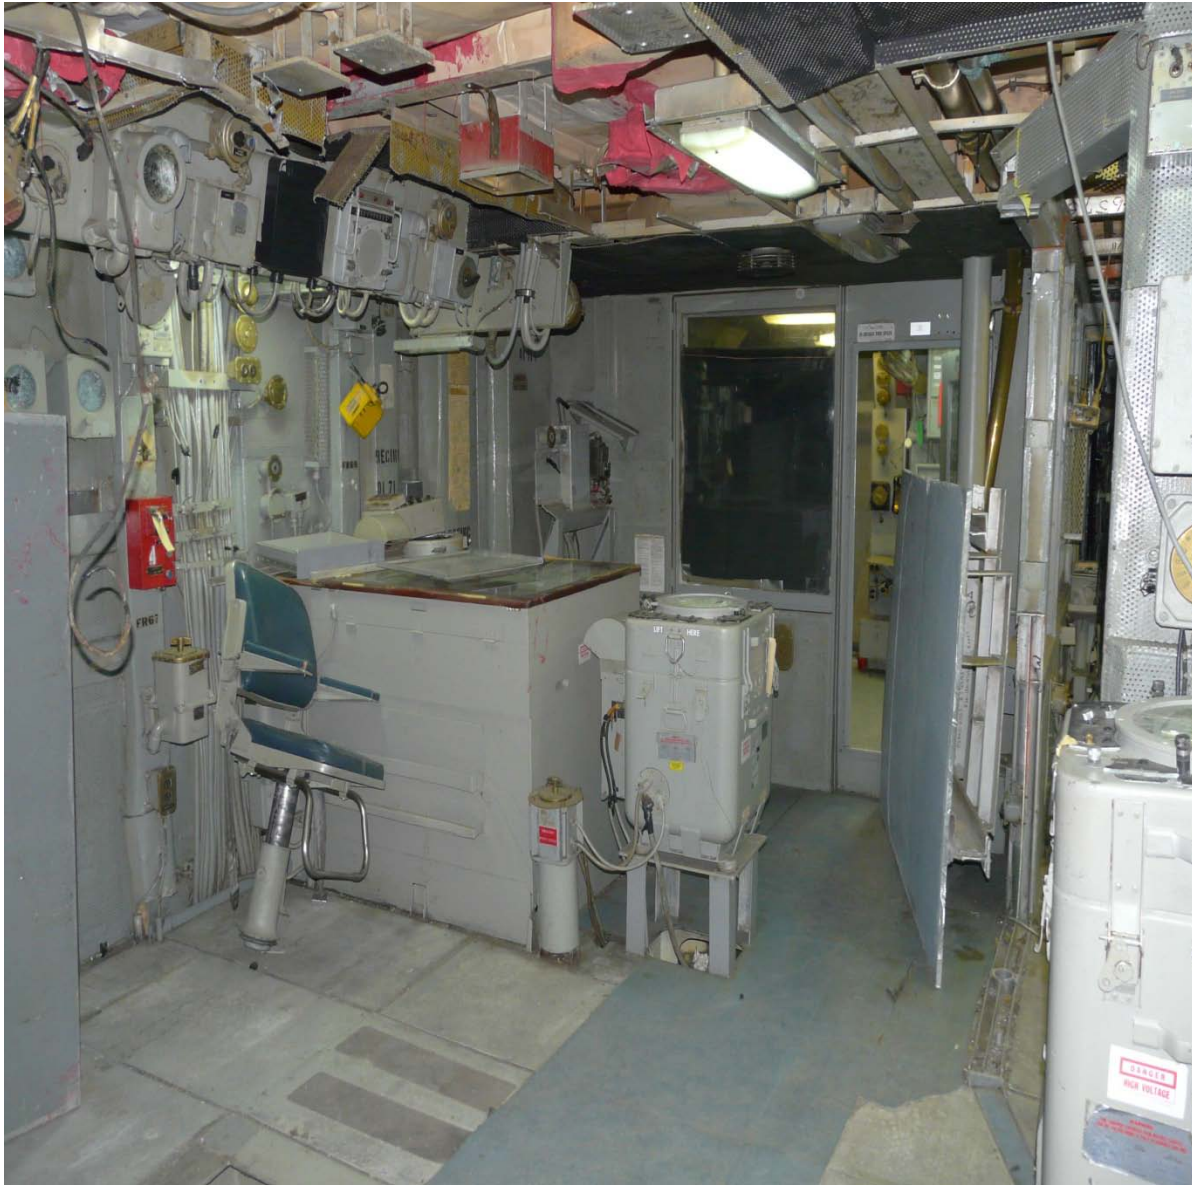
CIC

Looking aft along the starboard side. NC2 Plotter is missing.

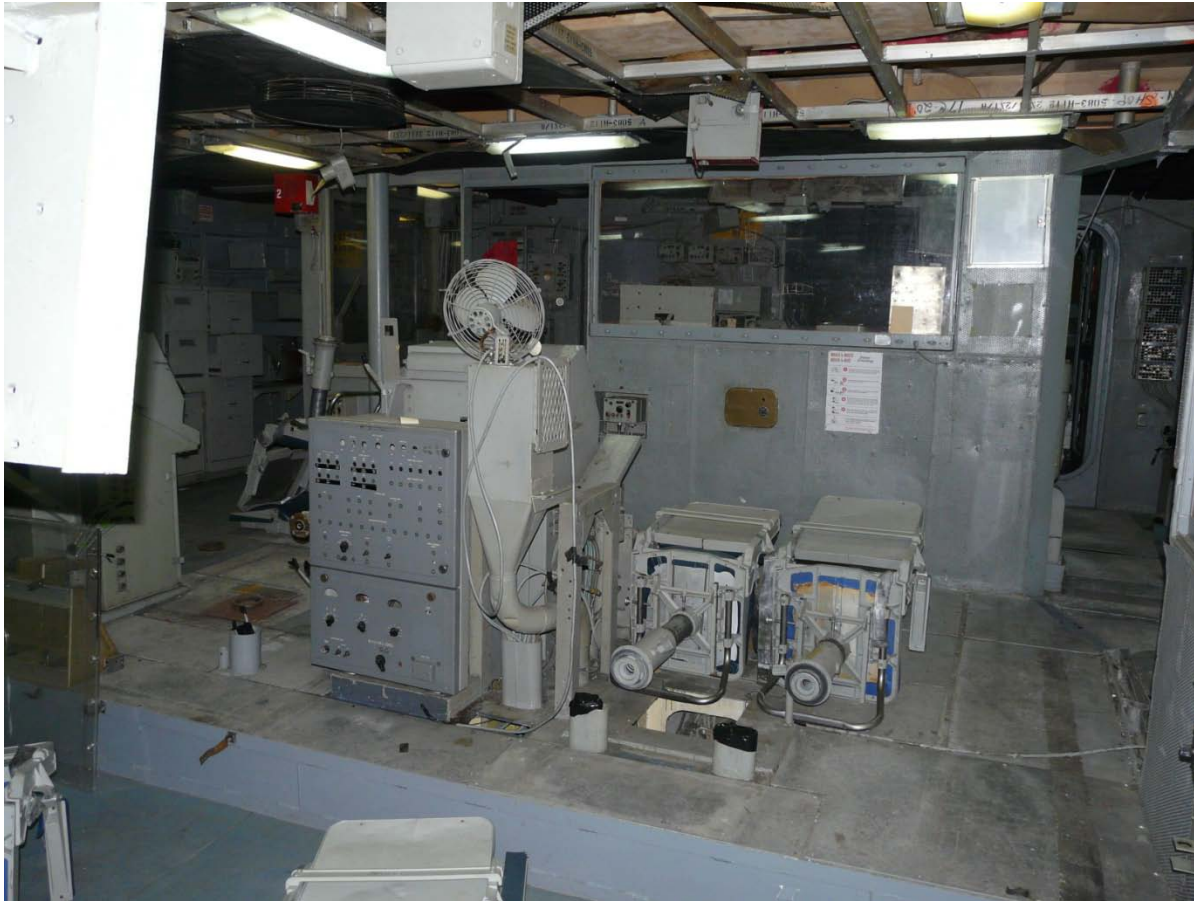
CIC

Aft looking forward. Notice the missing consoles.

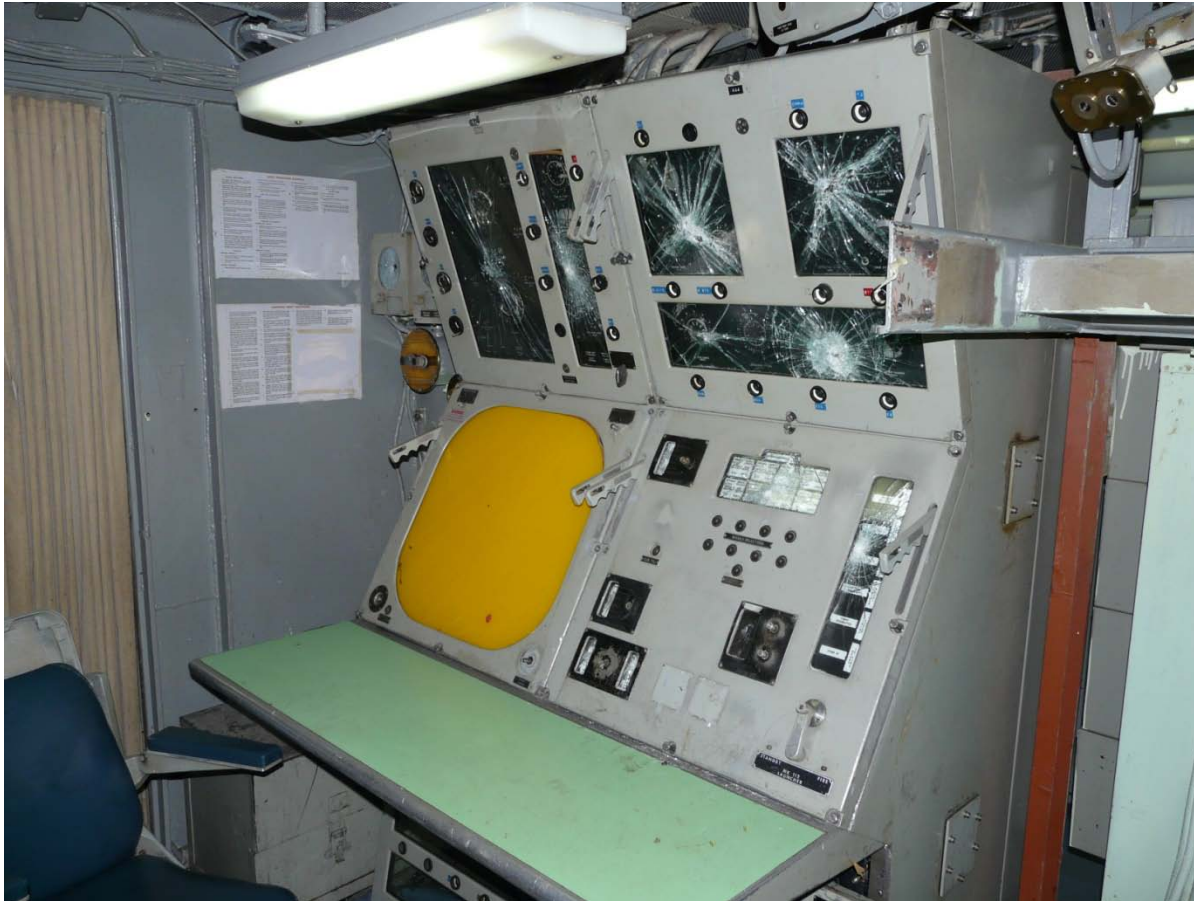
Sonar Room

DEMILED Sonar Console.

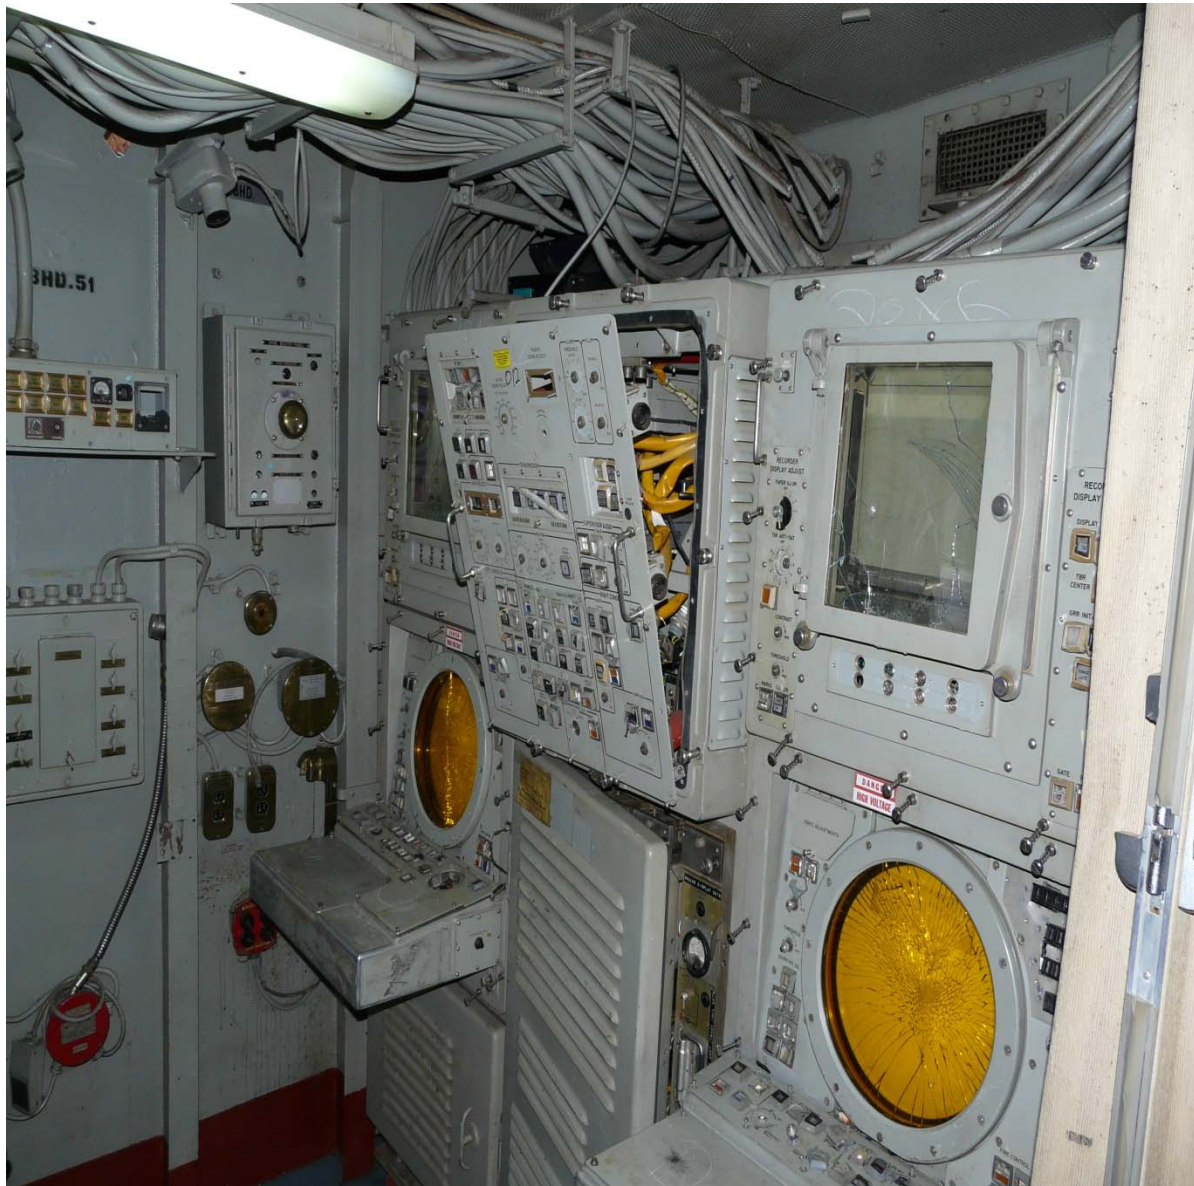
Sonar Room

Additional sonar consoles also DEMILED, but outer glass on scopes the only thing broken. Easily replaced.

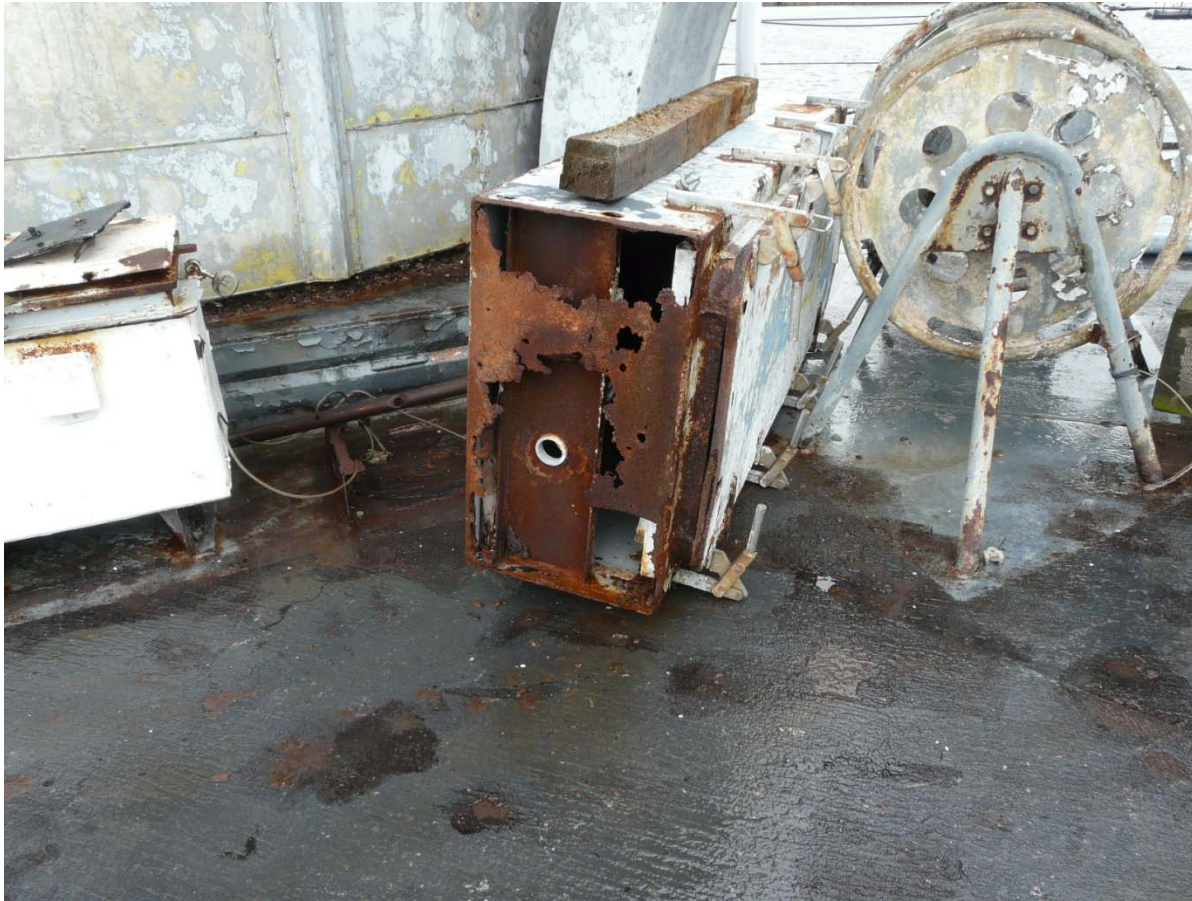
The cause of running rust.

All over the various decks are deck storage boxes, line reels, pipe fittings, sound powered phone boxes, and so on made out of steel. These items are rusting and causing running rust which drains over the side of the ship when it rains. These are the rust stains you see on the hull. The hull itself isn't rusting above the waterline. All the items mentioned above will be removed to get rid of deck clutter and safety hazards.

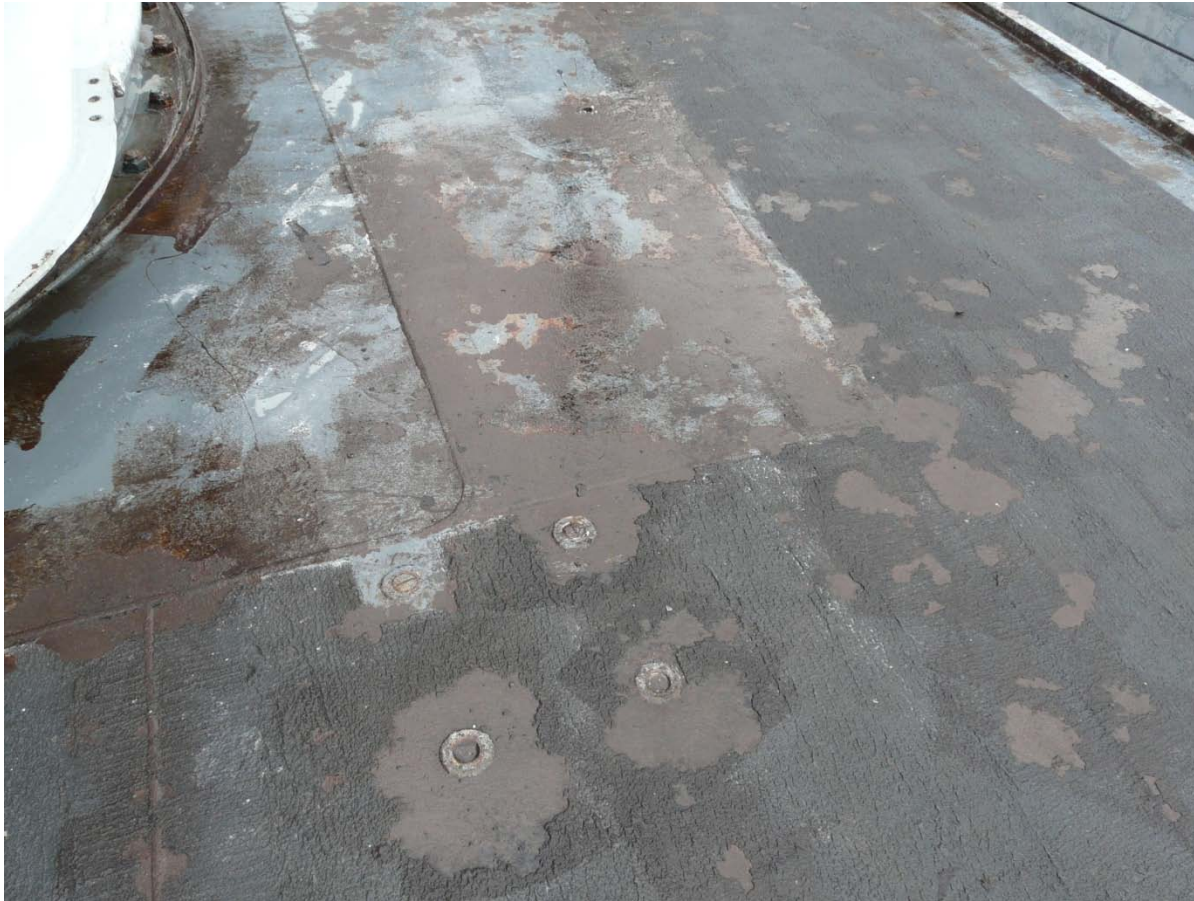
The Deck

Here is a photo of the deck itself taken near gun mount 51. Take note that you see that over the last 20 years non skid has flaked off.

There is a clear coat of a preservative that is made for steel on the entire main deck. This has prevented the deck from deteriorating further.

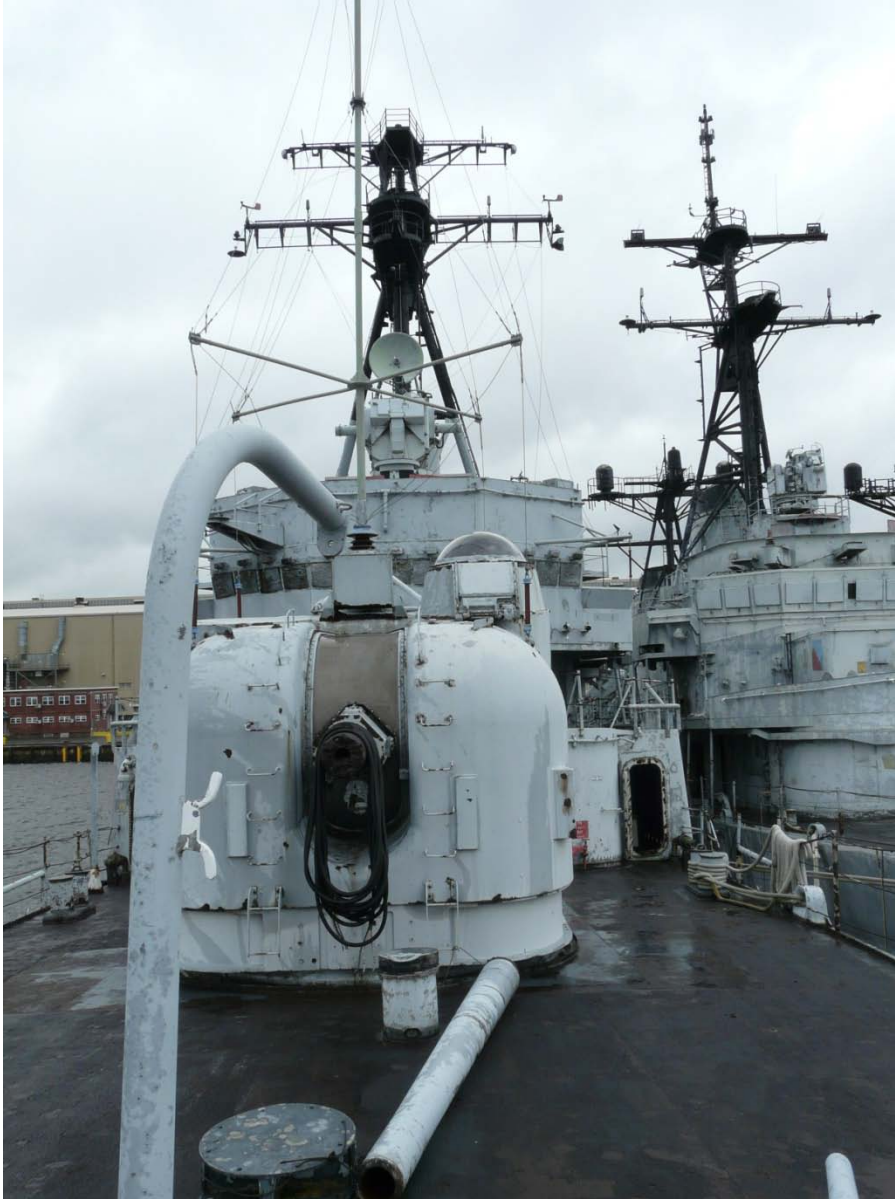
Main Deck

This is the main deck forward looking aft. The gun barrels from both guns have been cut off and welded to the deck. The antenna is still on top of MT 51.

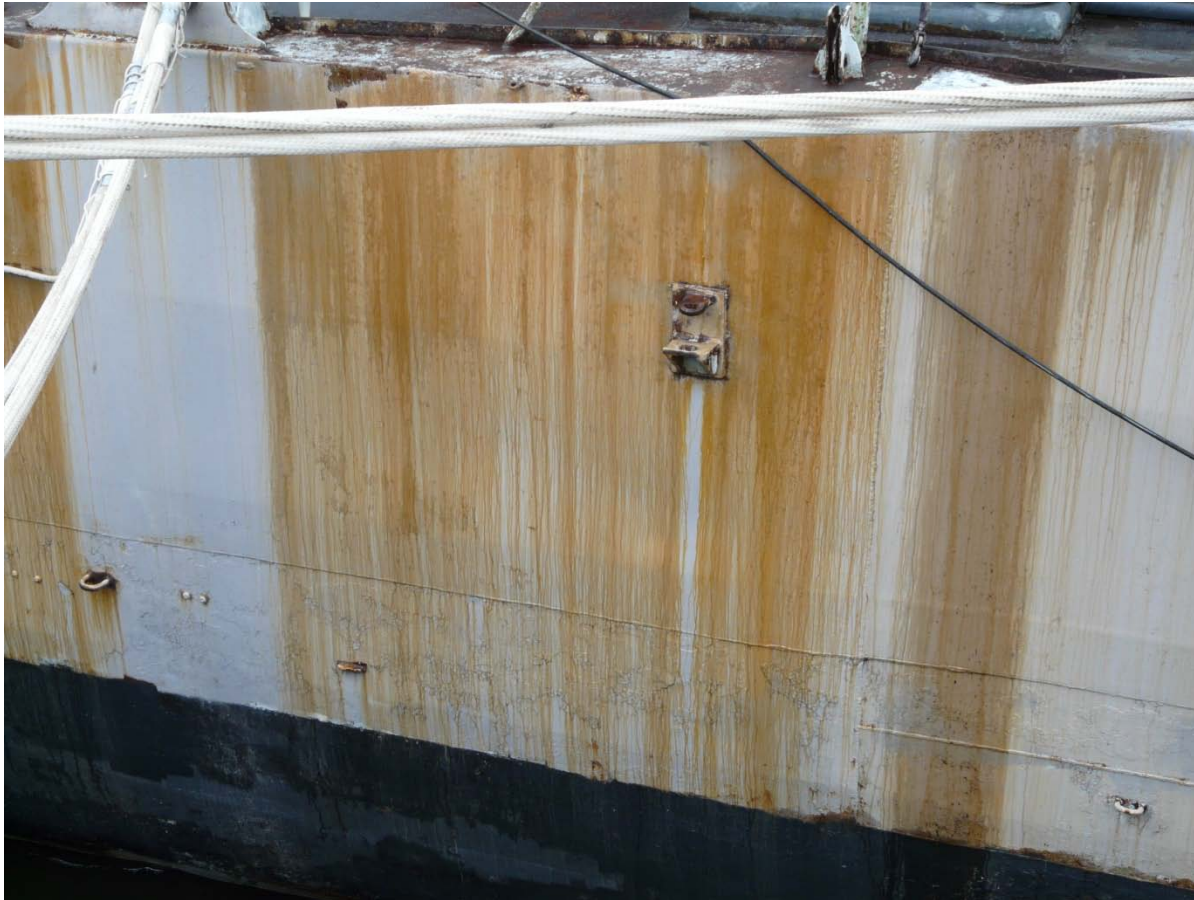
Port Hull Aft

Here is a picture of the hull with the rust stains. These are rust stains from the rusted out items like the deck boxes as shown on other slides. The paint job done two years ago has held up very well and isn't flaking or rusting..

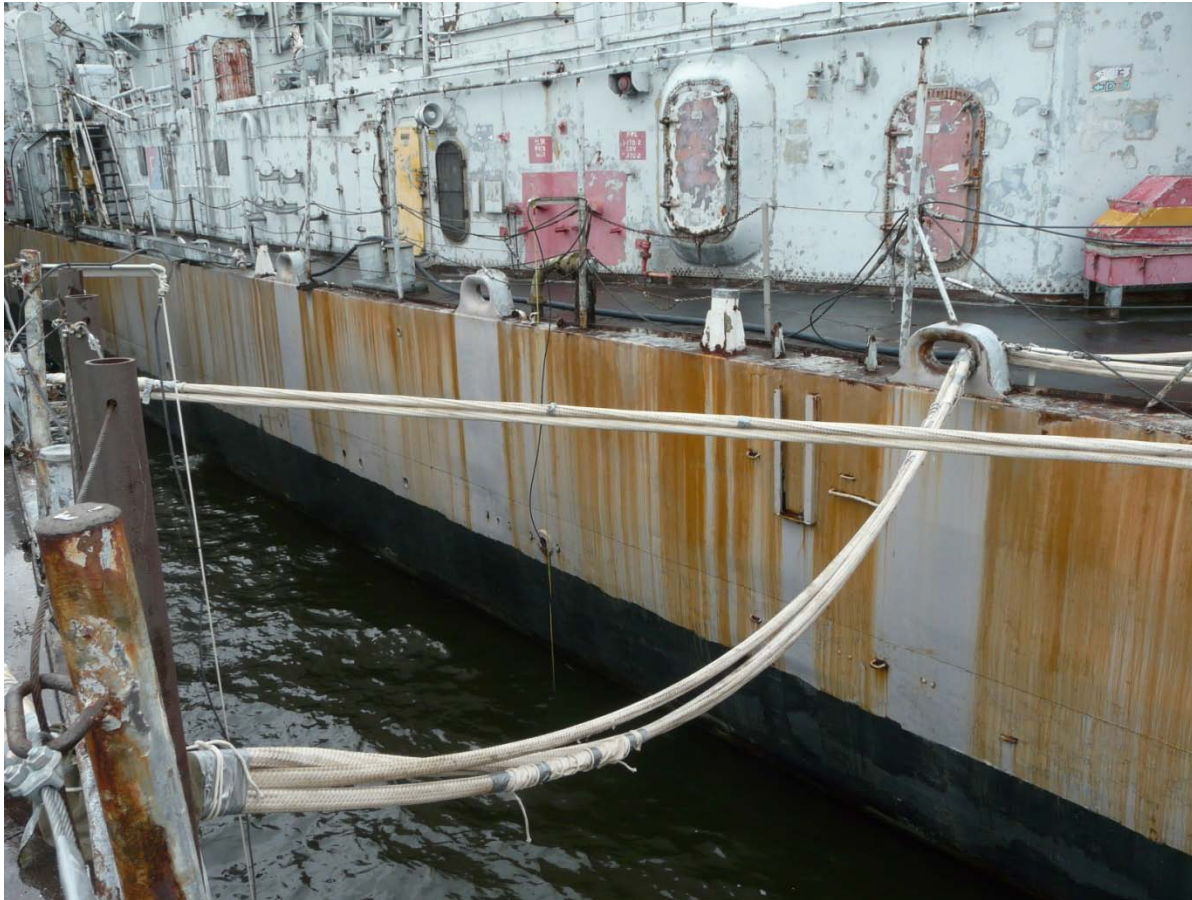
Port Side Aft

Another picture to show the rust stains coming from the run off on the main deck when it rains. Also note the aluminum bulkhead. The issue here is just flaking paint.
