USS Charles F Adams DDG-2 Philadelphia Open House

May 17-18, 2010

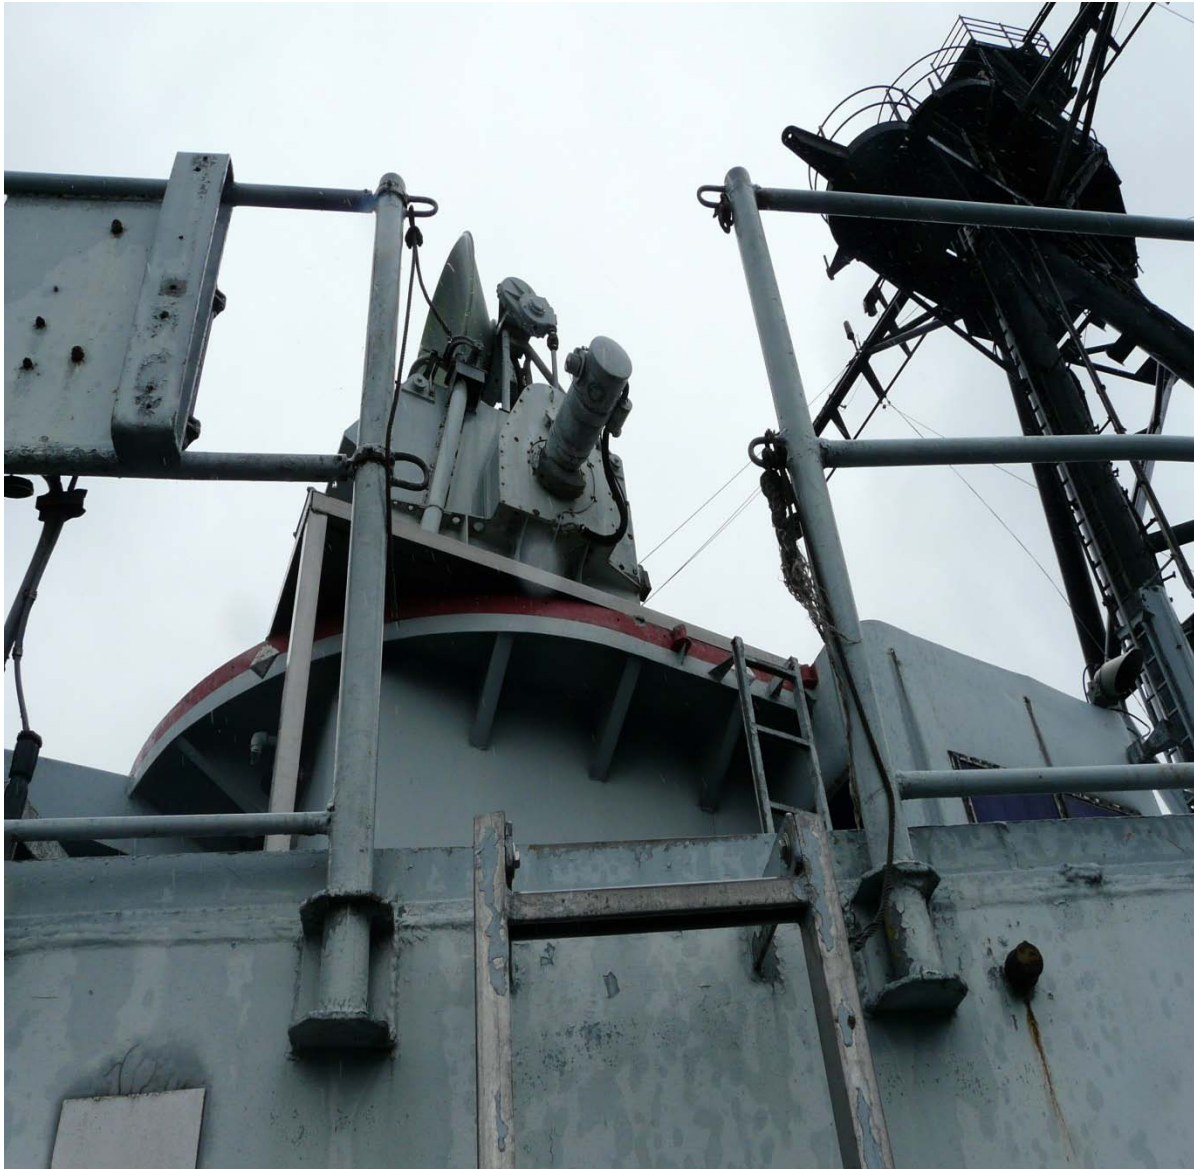
Bridge Wing Port Side

This was taken on the port side bridge wing looking up. Here you see the MK 68 Gun Director and the main mast.

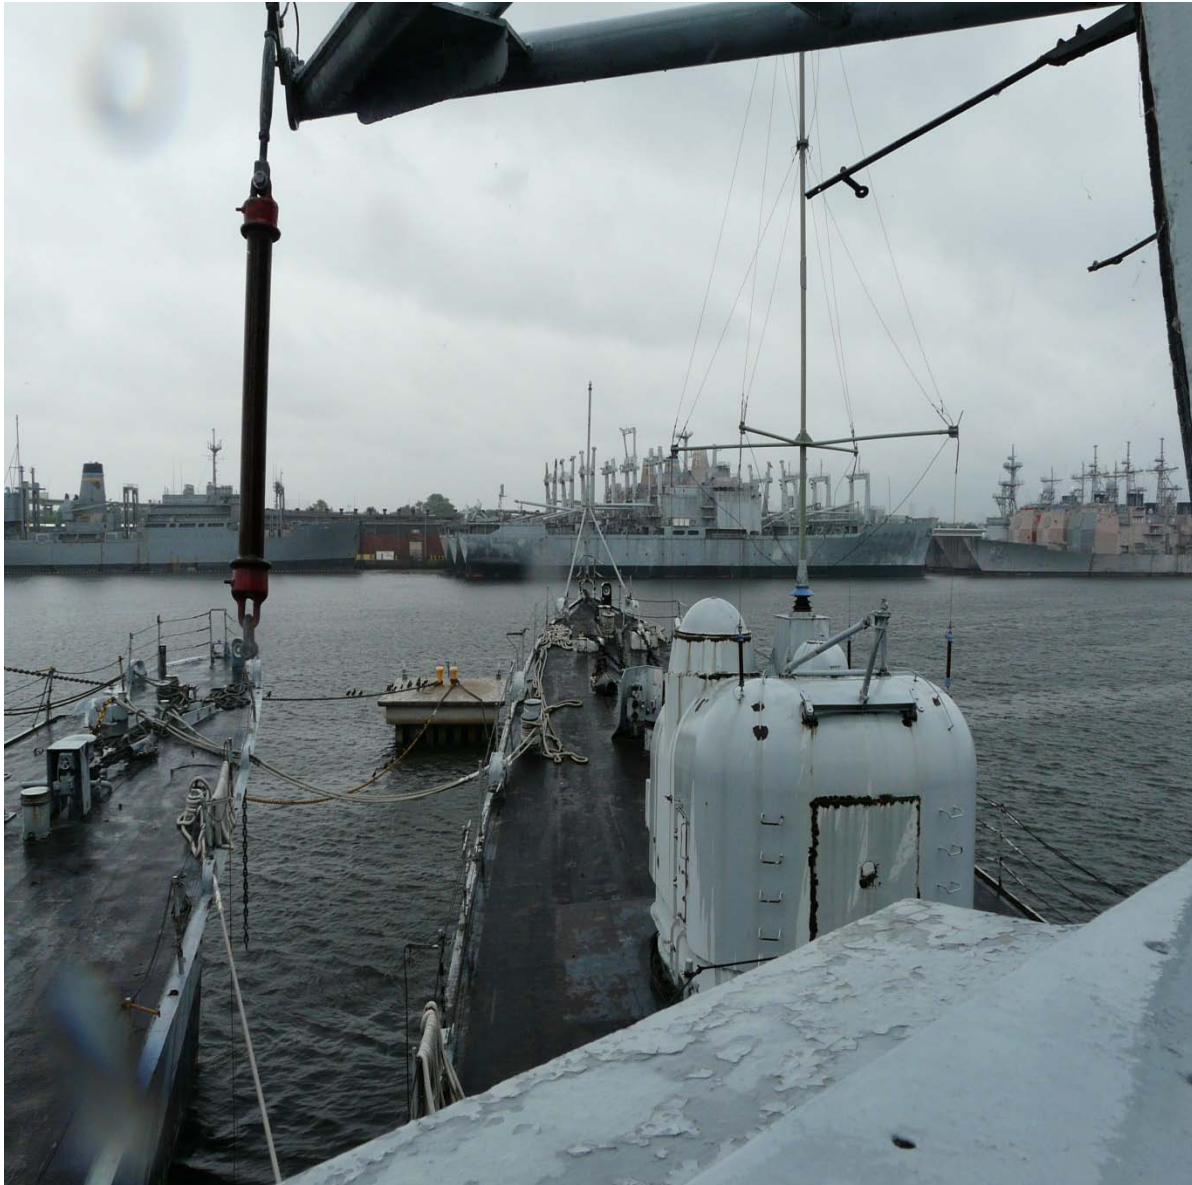
Port Bridge Wing looking forward

Note the antenna that is still on the gun mount. The ships on the right in the distance are the Aegis Cruisers where we removed equipment. The ship on the right is the USNS Saturn where we got the signal lights and fire main fittings. If you look at the main deck, a good deal of the non skid surface appears to remain intact.

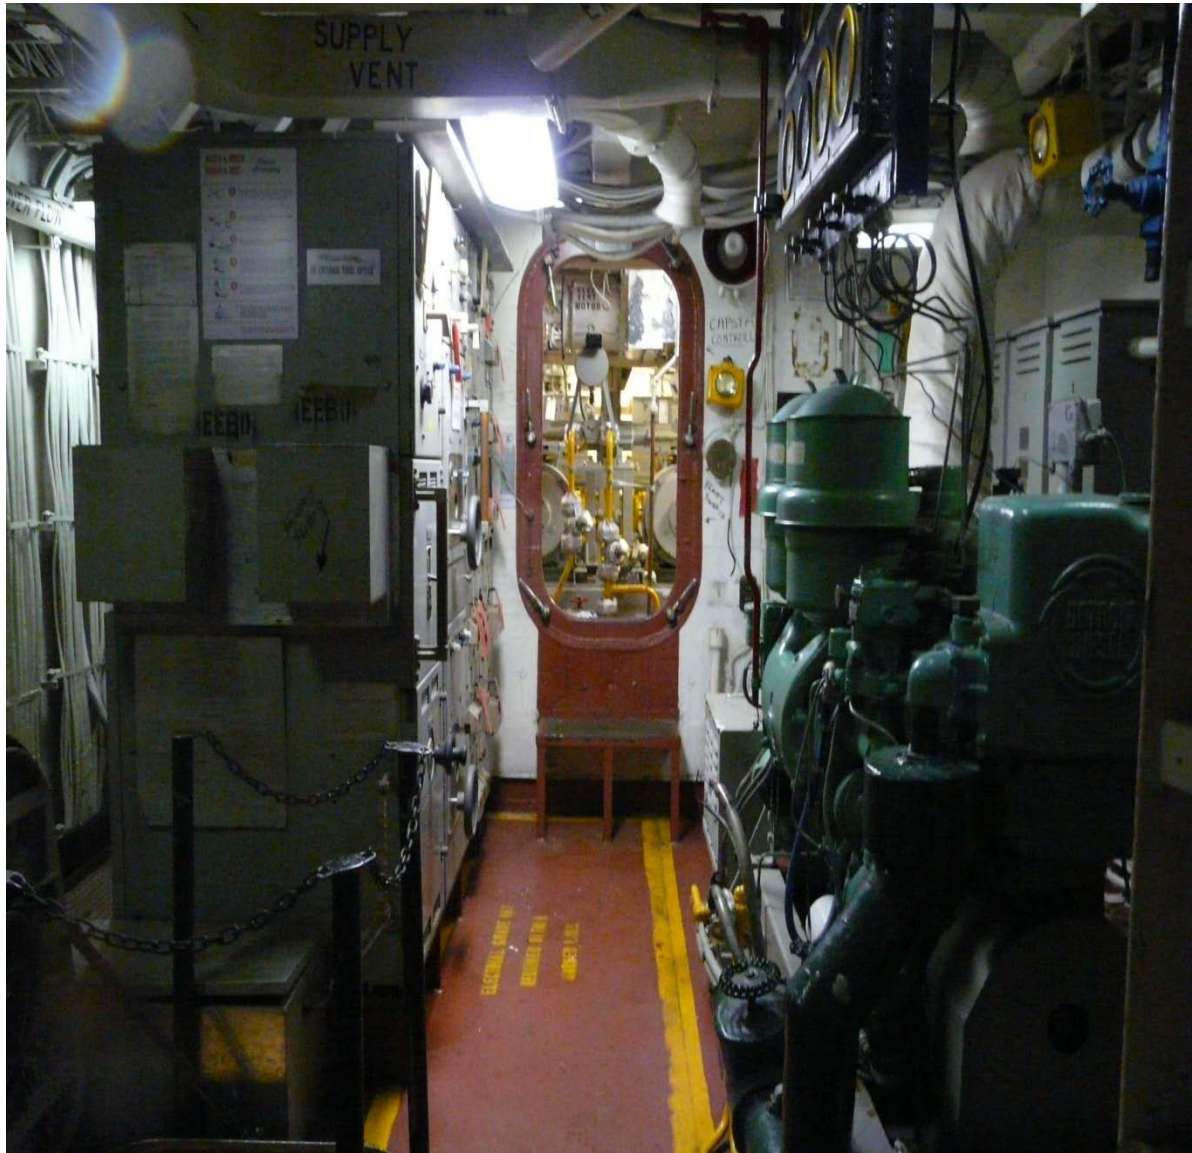
After Diesel

The entrance to after diesel looking aft into after steering. The generator and switchboard on the left appear to be intact.

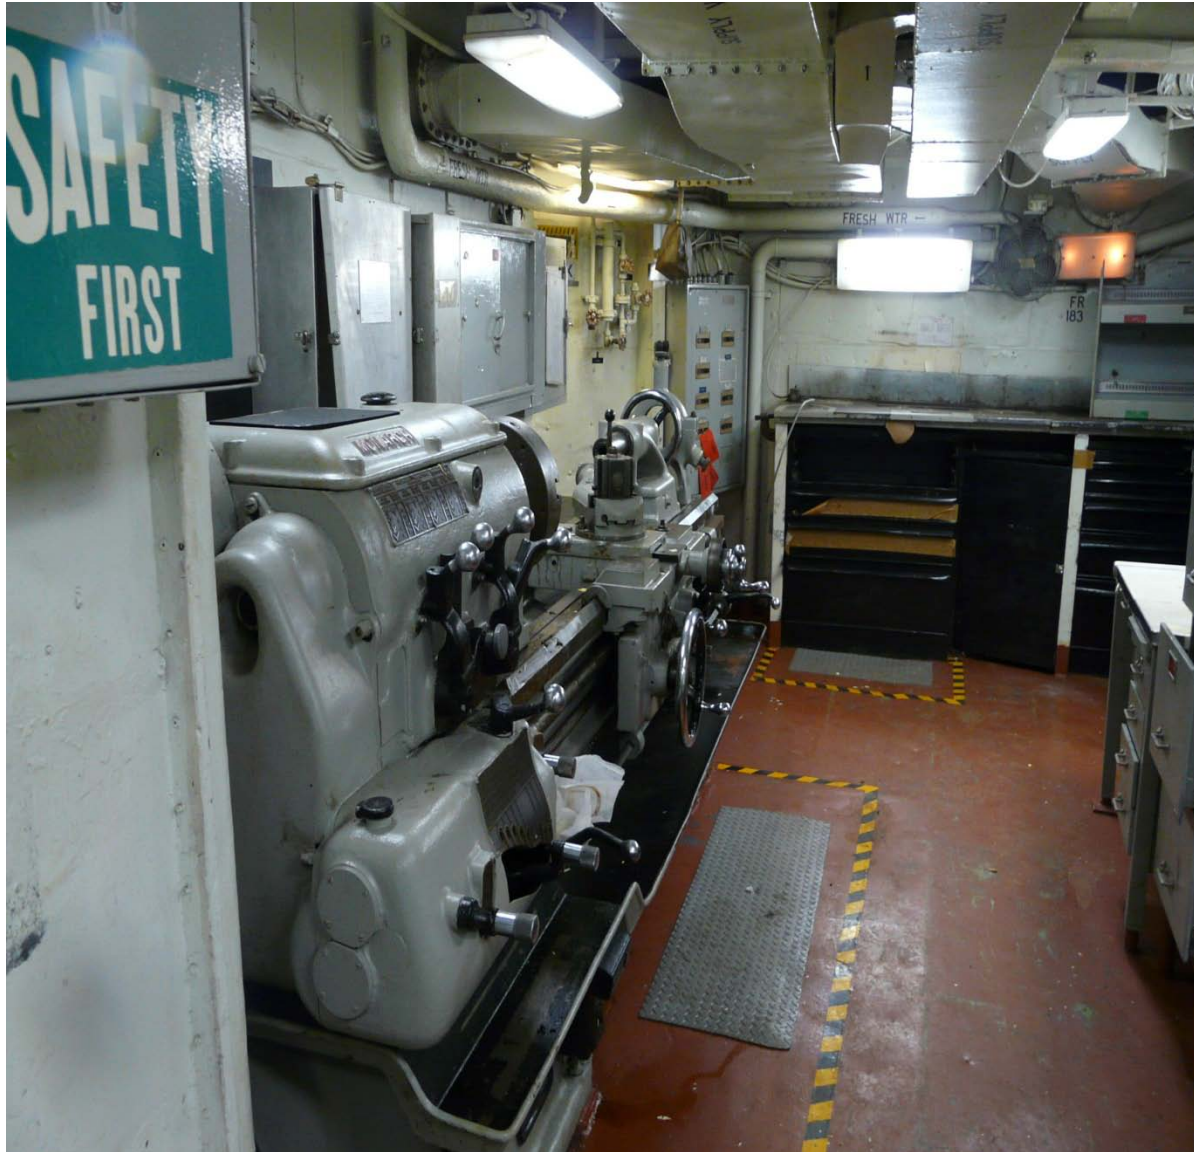
Machine Shop starboard side aft

Lathe on left is intact and there is other equipment located in the space.

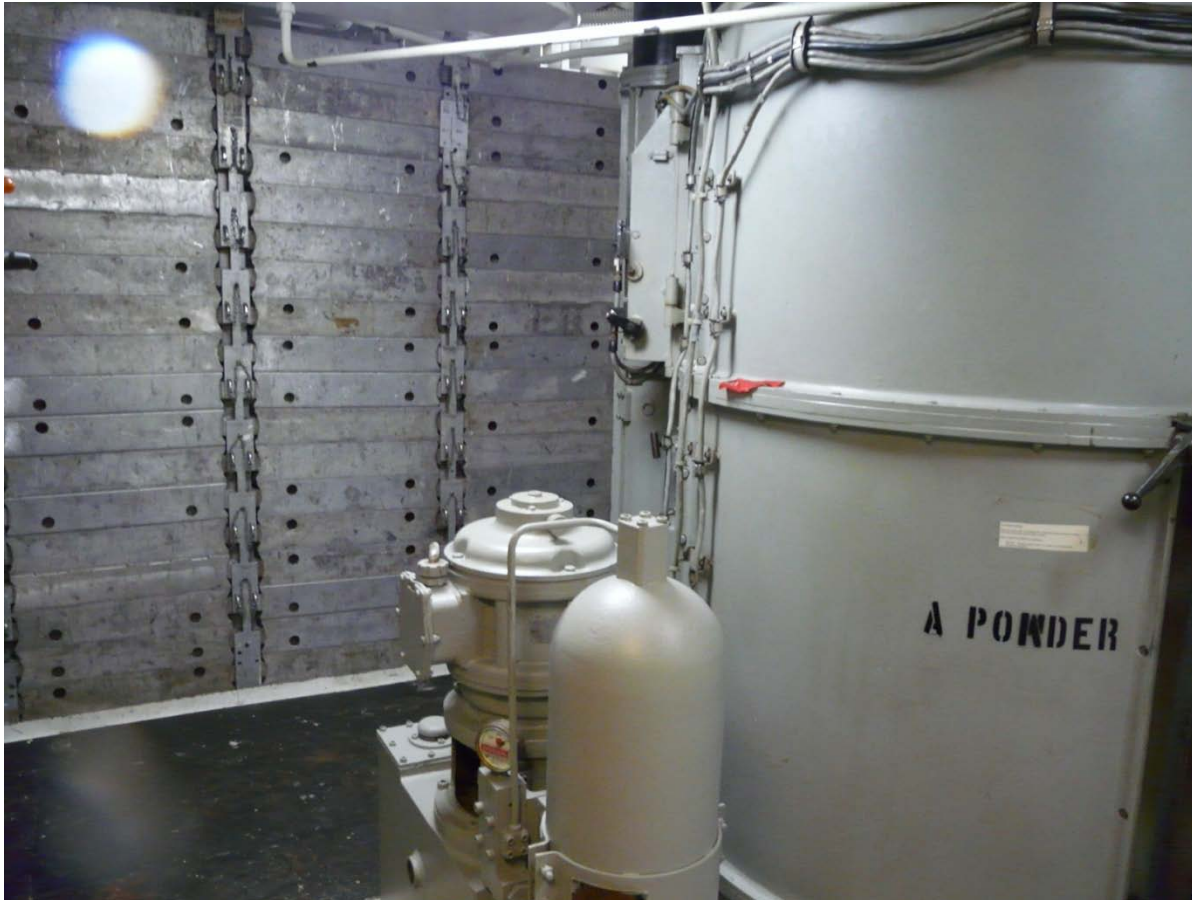
MT 52 Magazine

Here are the ammunition loader drums for the after gun mount in the magazine. All powder and “bullet” racks are still present and no DEMILING has taken place here. There was no water infiltration anywhere here in one of the lowest sections of the ship. This most likely will not be one of the areas that will ever be open to the general public due to its difficulty in getting down the vertical ladders.

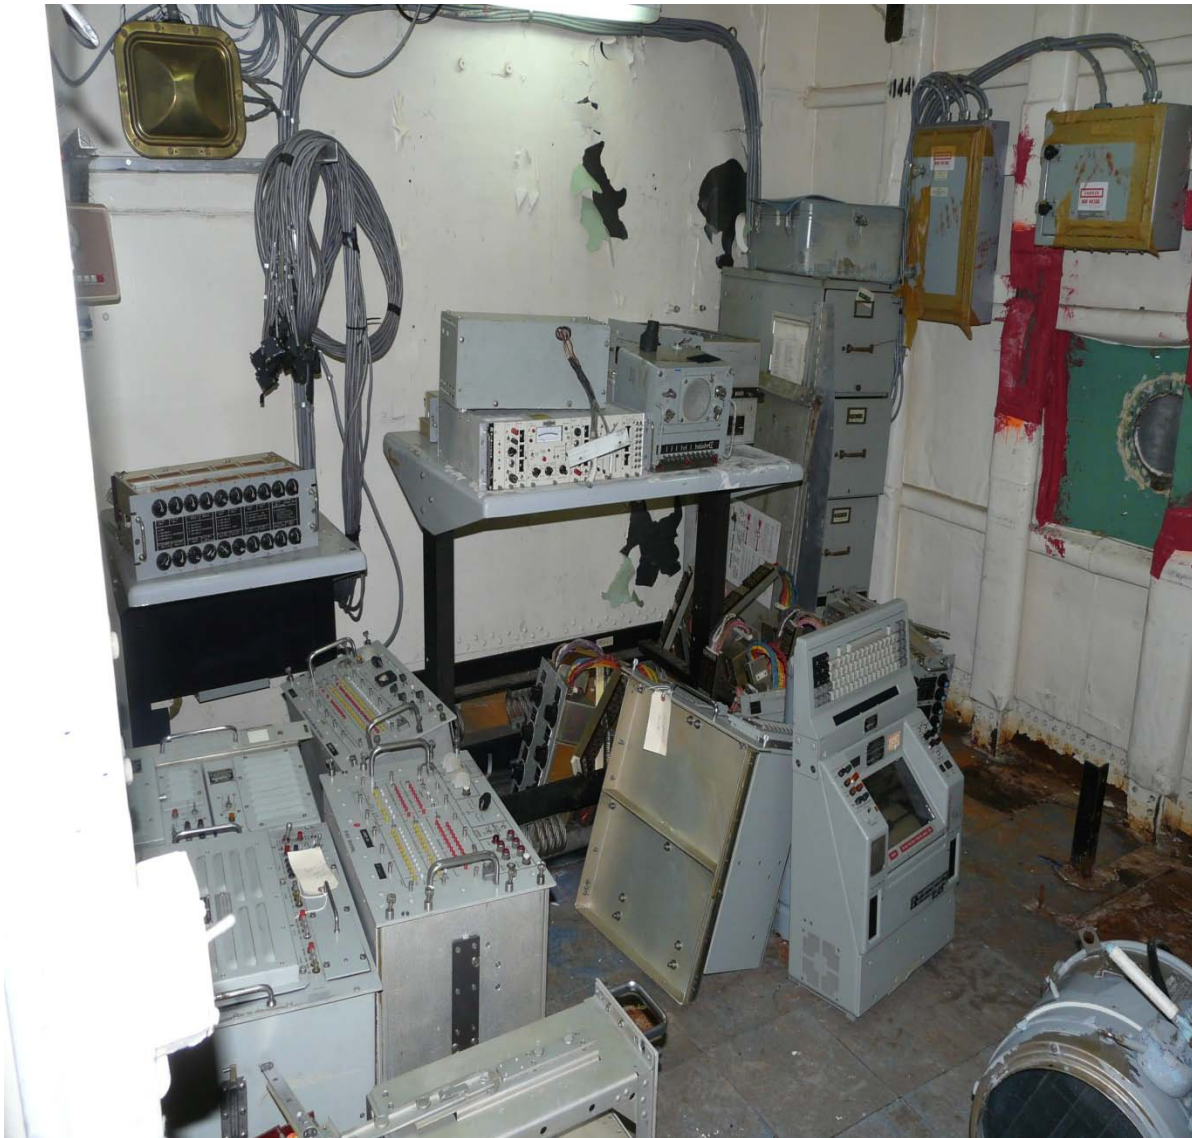
Office Space

This is the same space as the slide previous slide. Here is a selection of radio equipment that was removed from the USS Arthur Radford during the open house in May of 2009.

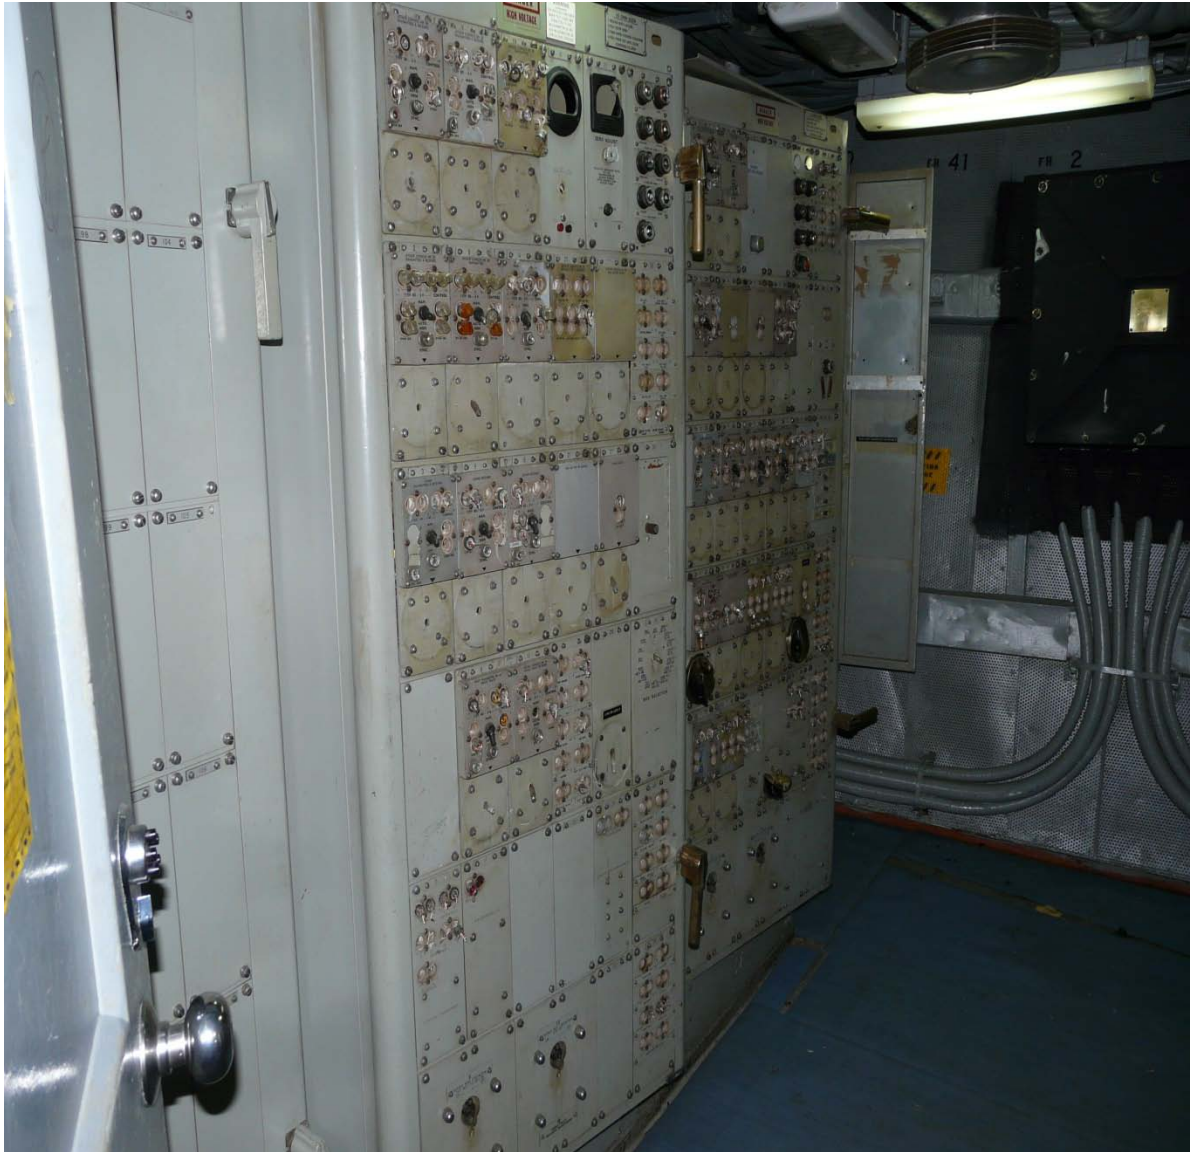
Sonar Room

Sonar switchboards which are similar in type to the missing ones in gun plot.

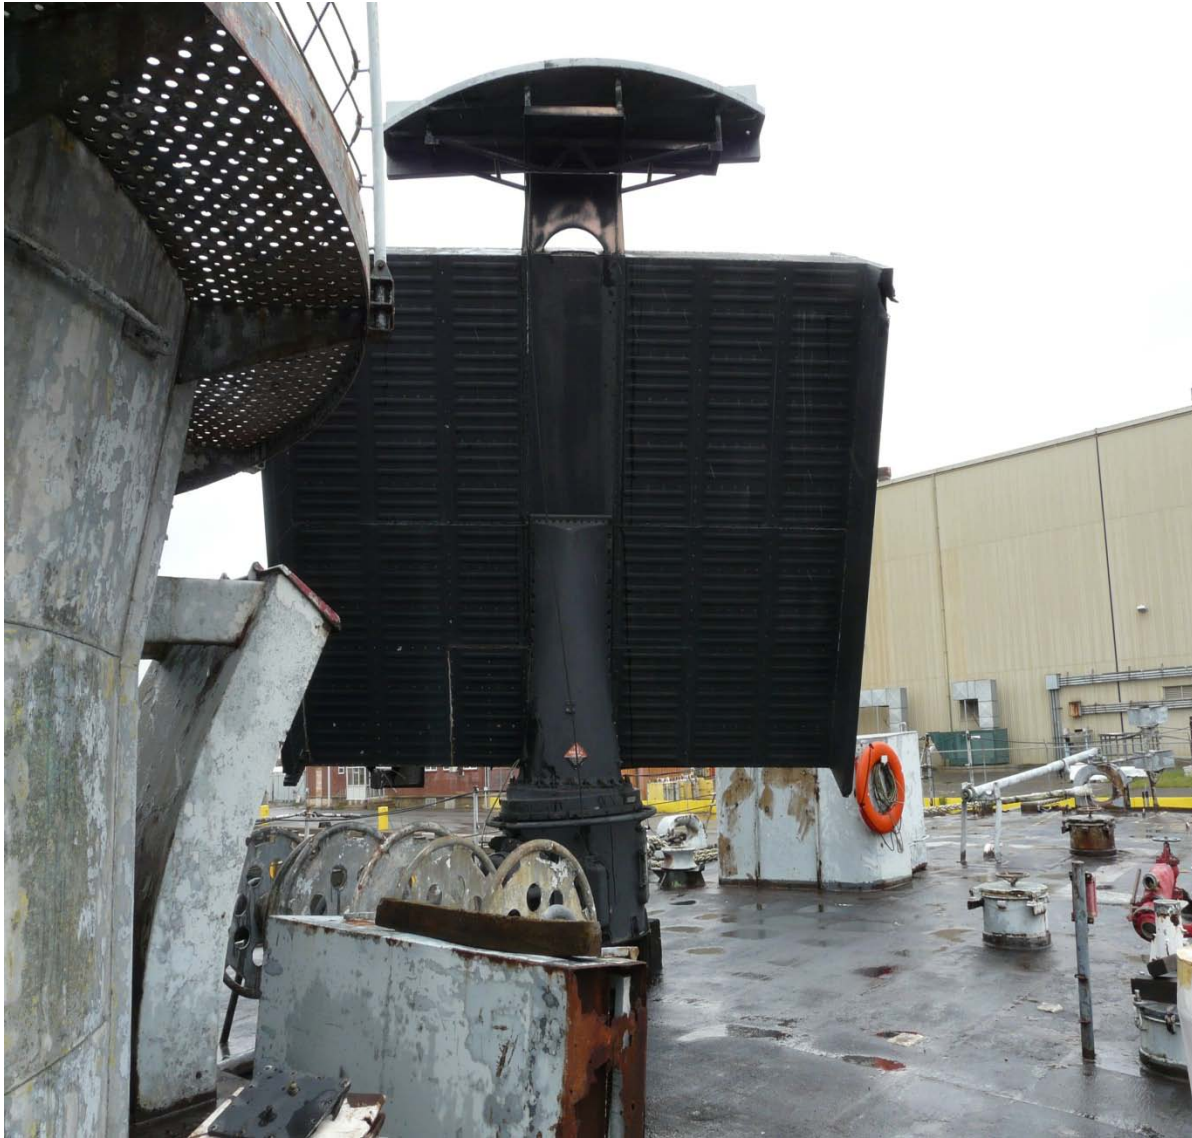
39 Radar

Looking aft on the fantail.

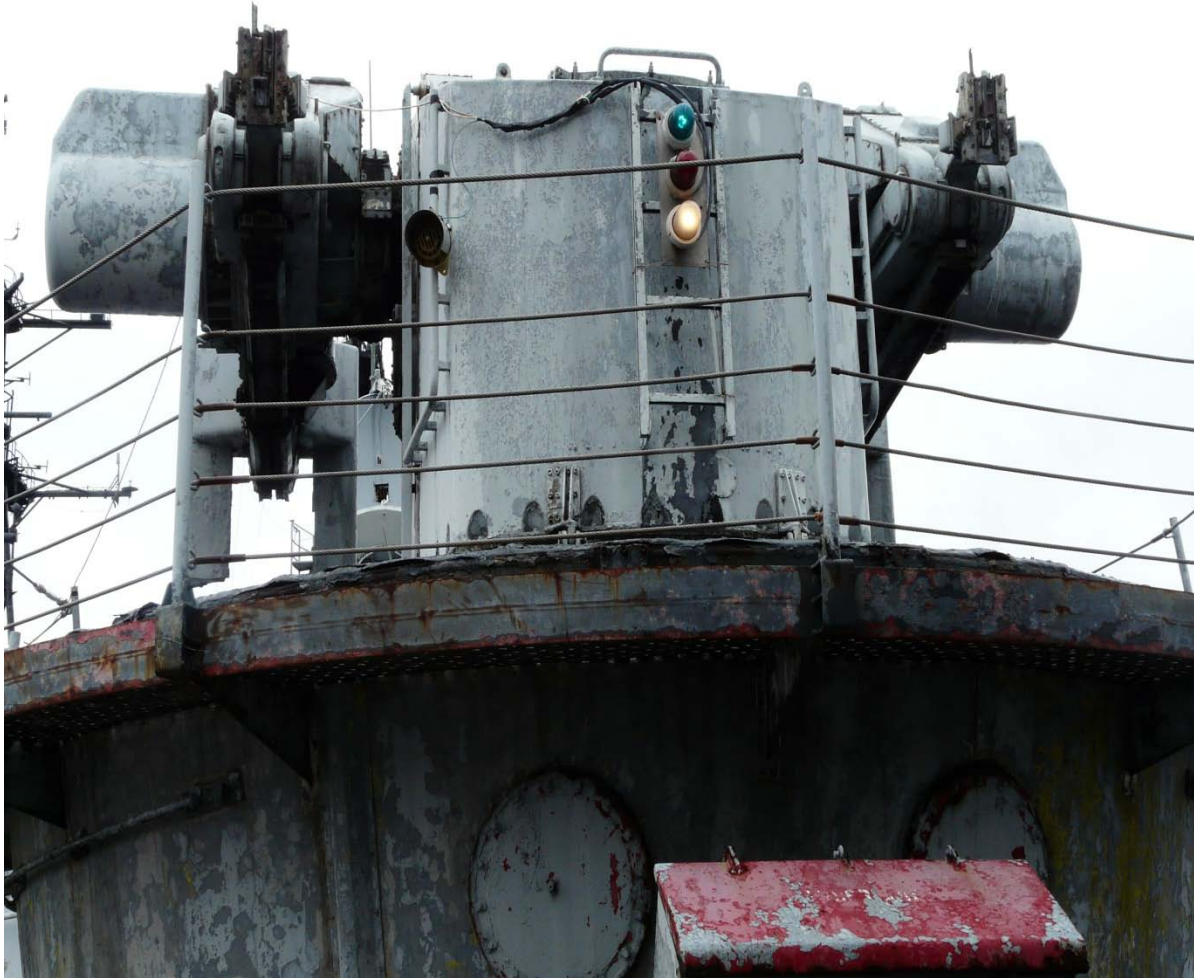
MK II Missile Launcher

From the fantail looking up at the launcher.

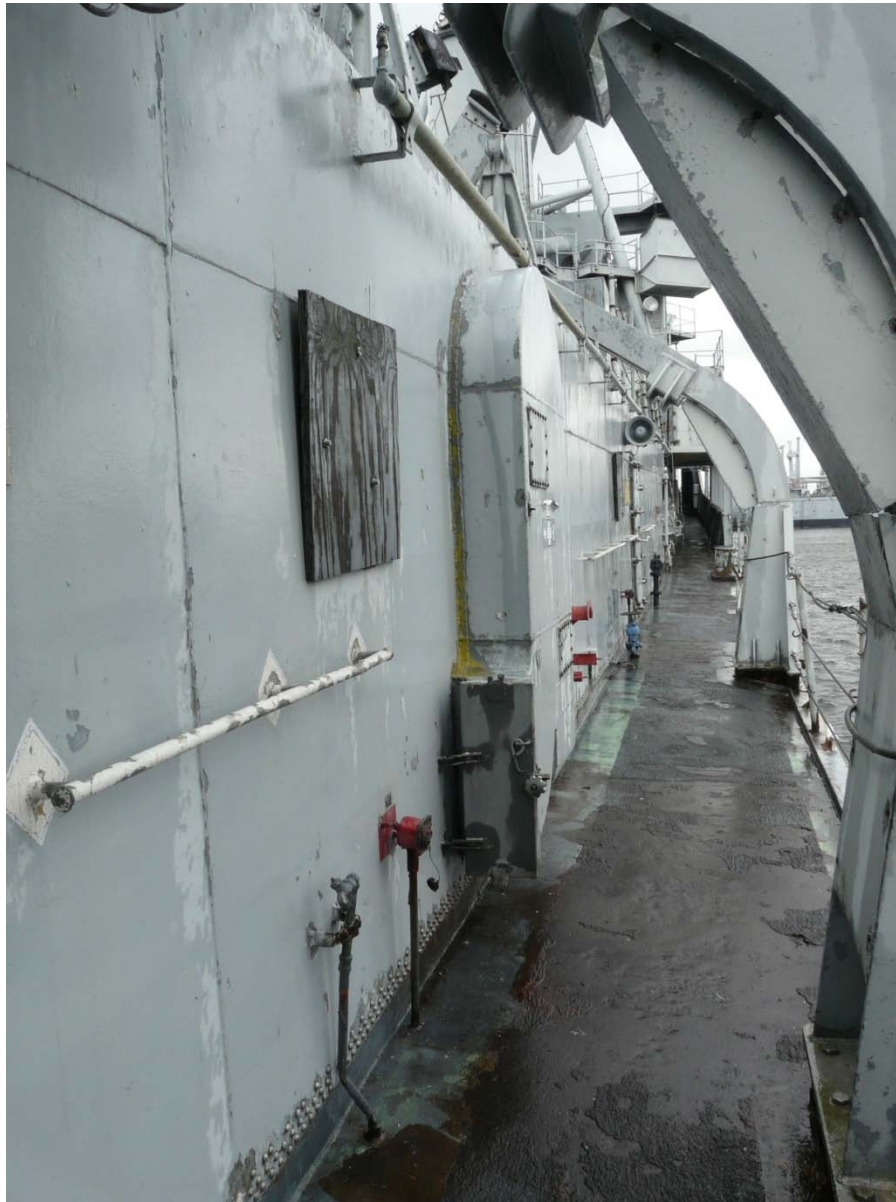
Main Deck

Main deck starboard
looking forward.

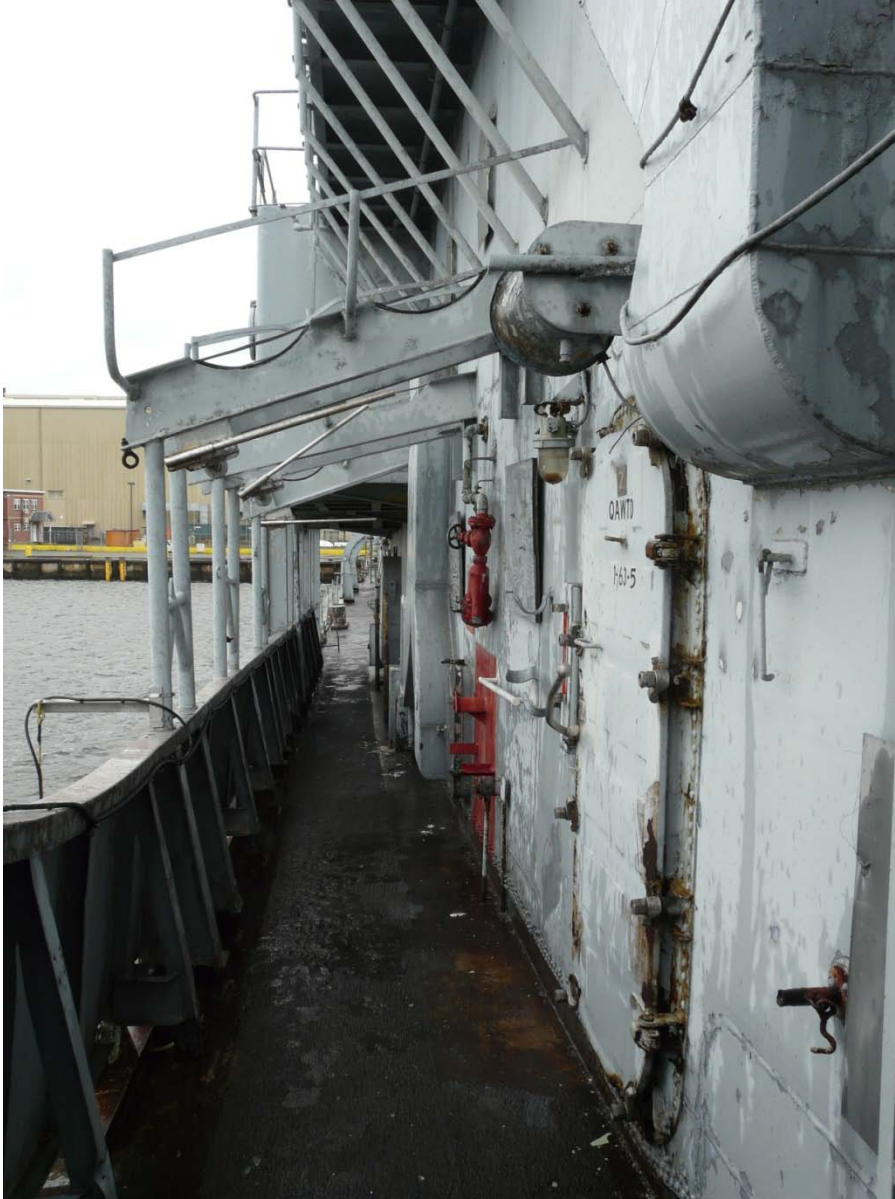
Main Deck

Starboard side main deck
looking aft.

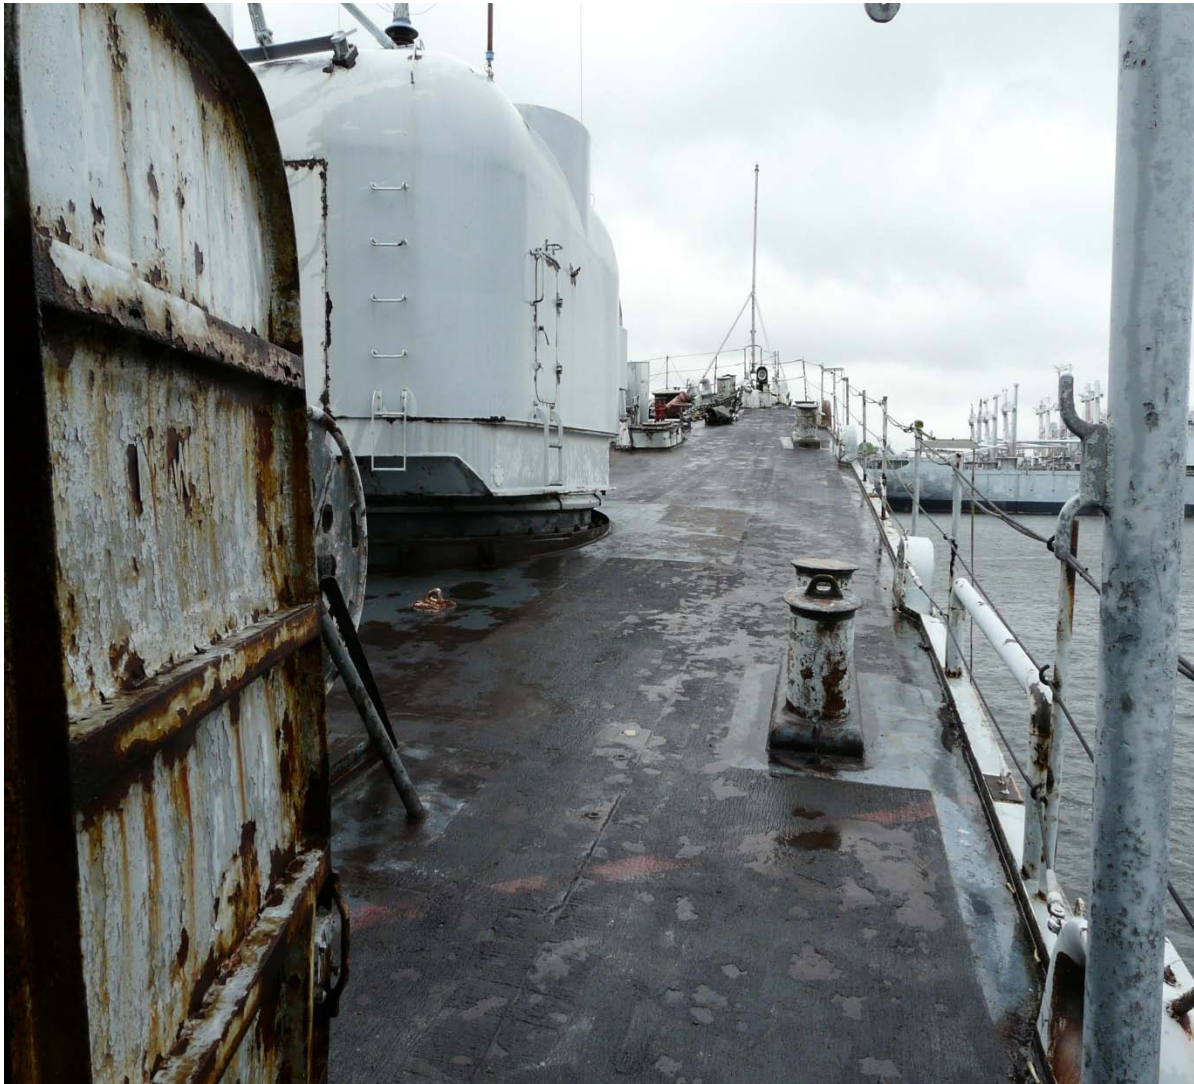
Main Deck

This is the main deck forward coming out of the hatch.
